■ Appendices

Appendix A—Injuries

CDF HELITACK 404 CREW BURNOVER

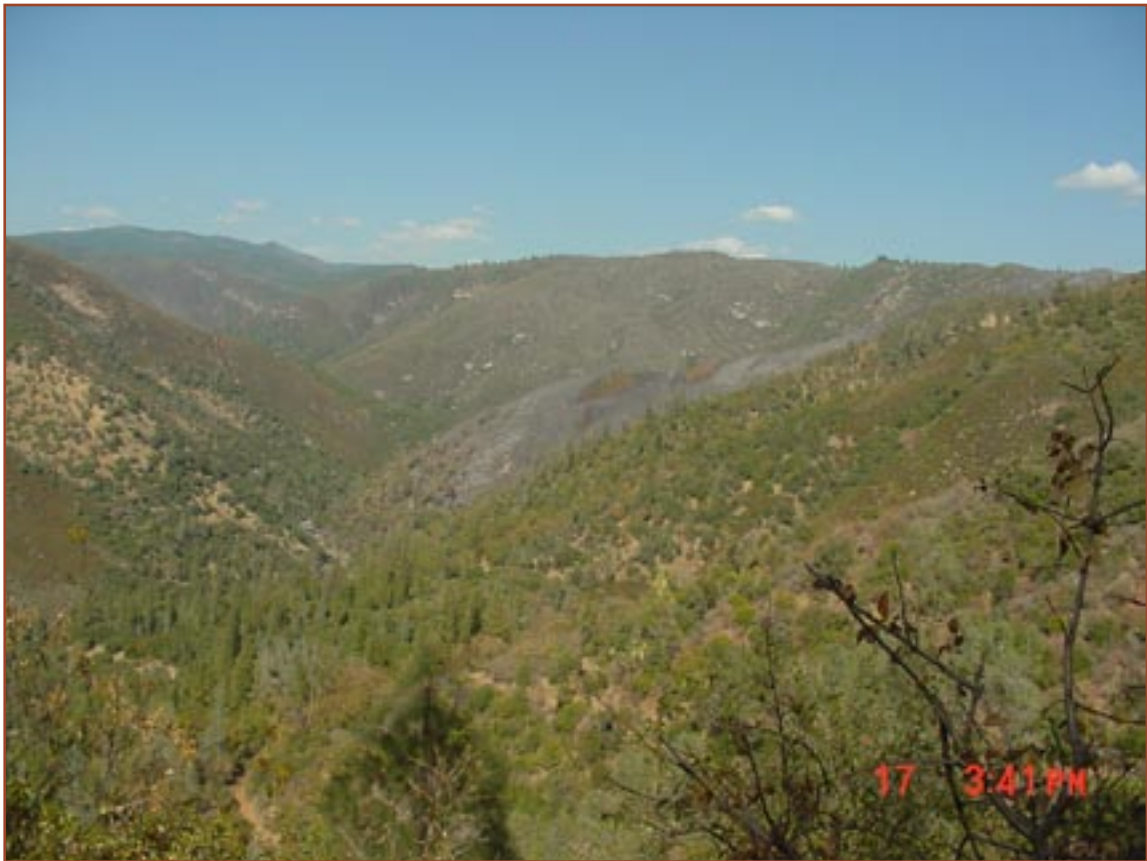
*Photo D-1: Tuolumne River Canyon looking northeast.
Tuolumne fire is located in the center of photo.
Accident site is obscured by ridge in foreground.*

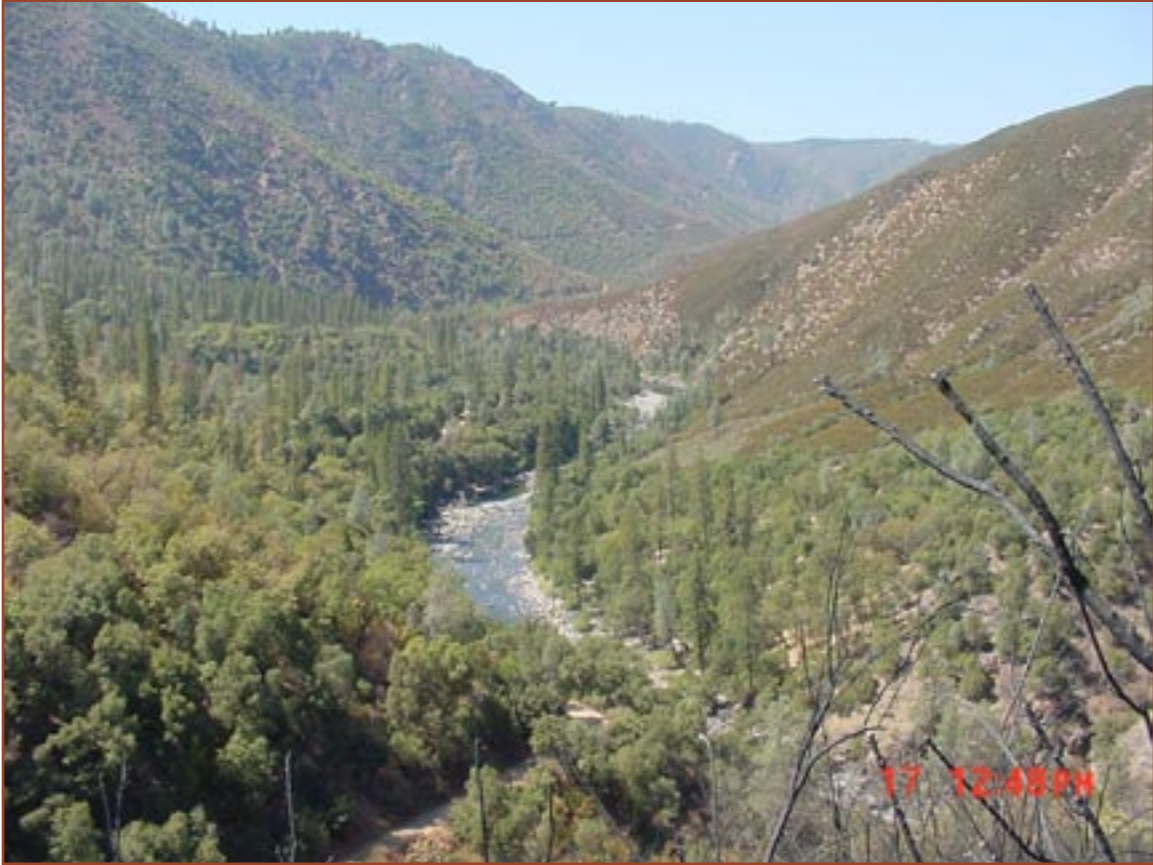
Photo D-2: Tuolumne River Canyon looking downriver to the west. Photo was taken approximately 150' above accident site. Accident site is not visible in this photo.

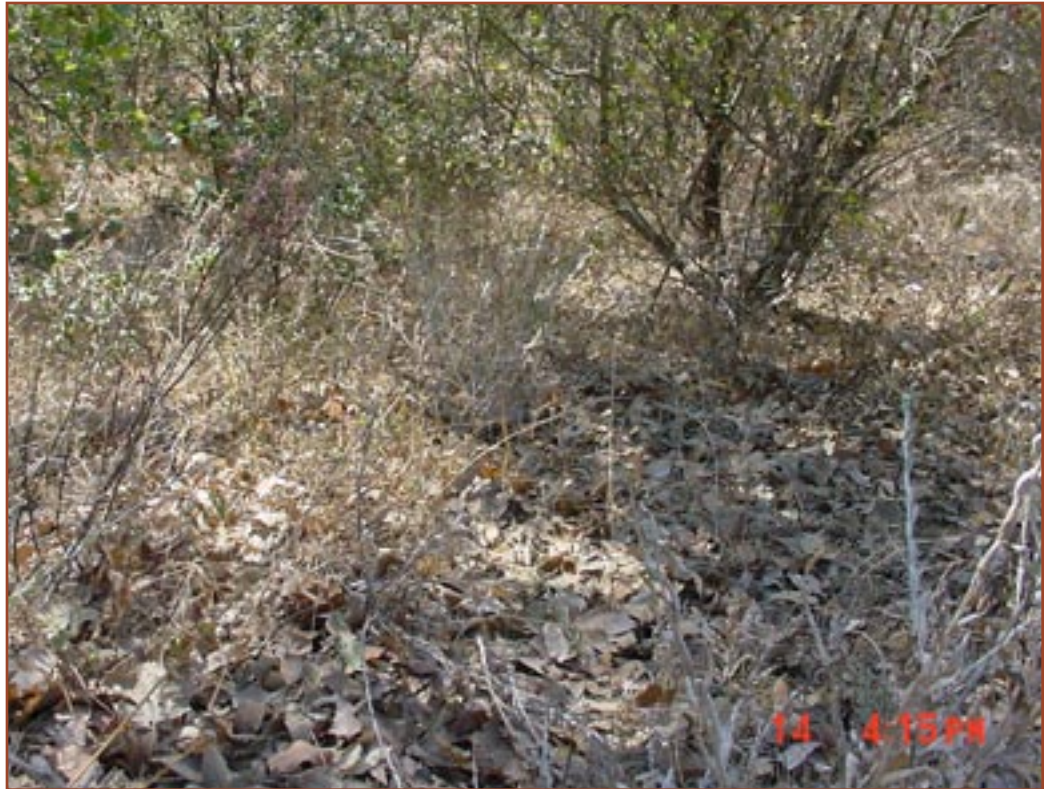
Photo D-3.
Surface
fuels
similar to
those in
which the
fire was
burning.

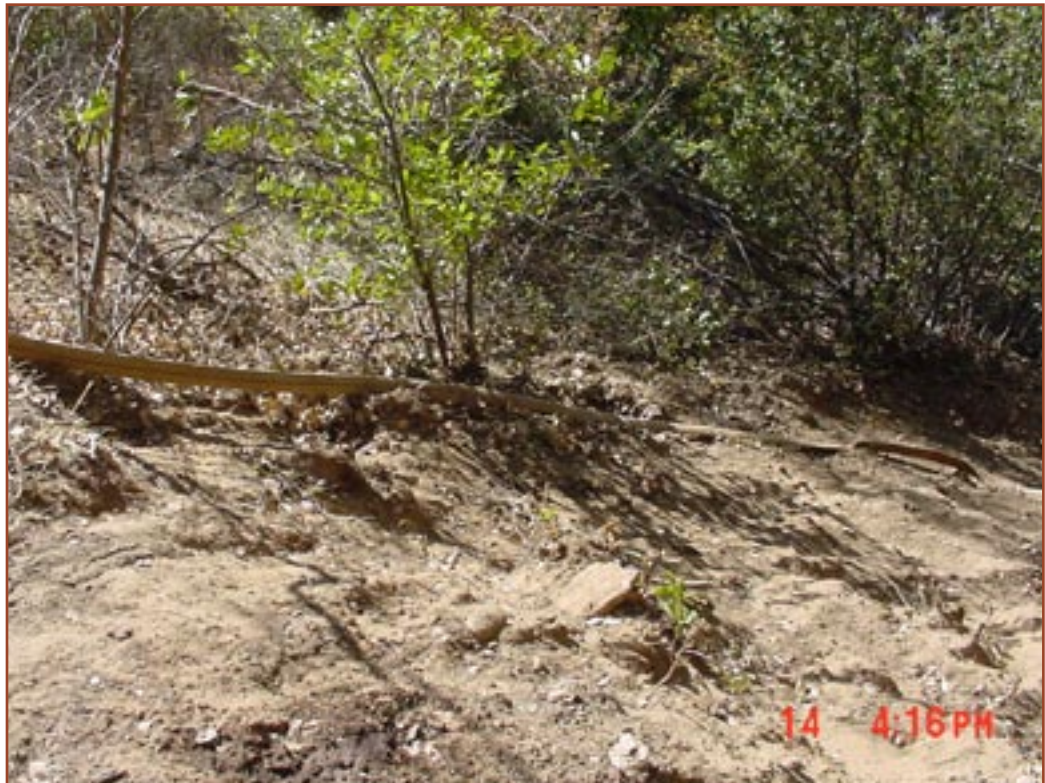
Photo D-4.
Unburned
fuels just west
of final fireline
below road.
Final right
flank fireline
is in the
foreground.
This was
approximately
100 feet south
of accident
site.

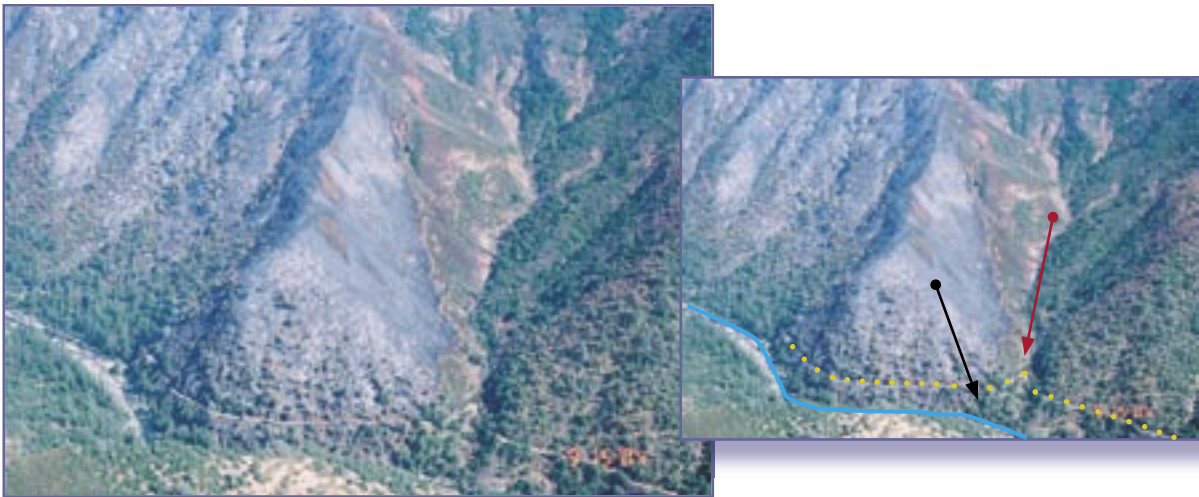
Photo H-1. View of lower fire area and accident scene. Tuolumne River (blue line) runs from lower left side (upstream) to lower right of photo (down stream) with north to the left of the photo and south to the right. Photo taken generally from west to east. Drew Creek (red arrow) is visible to the right of burned area. Lumsden Road (yellow dotted line) runs above the river on the southeast side and is visible near the bottom of photo. Accident site (black arrow) is located on the slope below the road and just above the river, just inside the right flank.

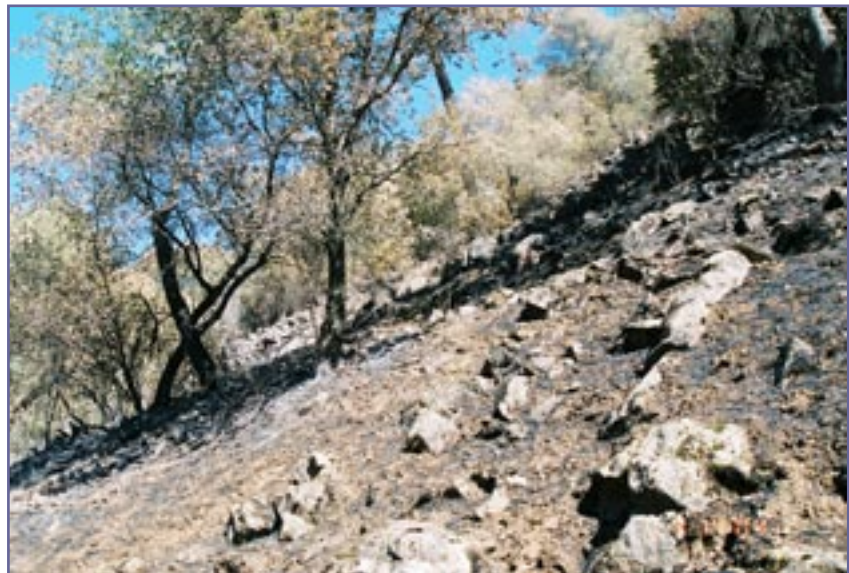
Macro burn indicators above the road, including degree of burn indicators, ash deposits and the relatively close alignment of the right flank above and below the road at the time of the accident indicate that the fire above the road moved up-slope and toward the south at a faster pace and burned hotter than below the road. This increased lateral spread indicates that fuel continuity and variations in the winds played a greater role in the spread of the fire above the road on the west aspect. This is consistent with wind conditions noted during the week and a half after the fire (see conditions section), smoke conditions noted during the final frames of the air attack video taken about 15 minutes prior to the accident and comments from the air attack expressing concern about the fire hooking below the retardant line on the right flank. Based on post-incident wind observations, this increased fire spread to the south would be expected to increase higher up on the slope.

Photo H-5. View of west slope showing heavy deposits of white ash above the road consistent with hotter burning and higher fuel loads in this area. Below the road only isolated small patches of white ash are present with the decrease even greater near and at the accident site.

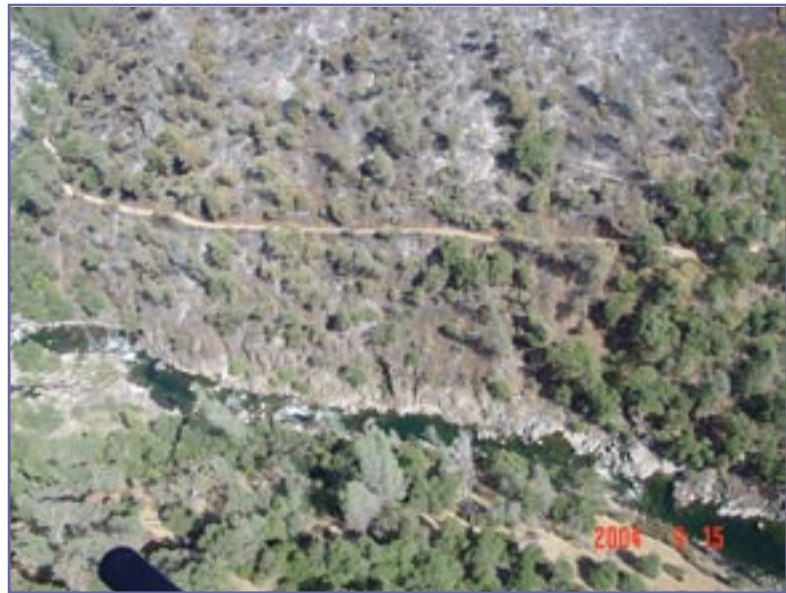
Photo H-6. View just up-canyon from accident site. View shows fuels and topography where fire was backing into wind toward accident site at right out of photo.

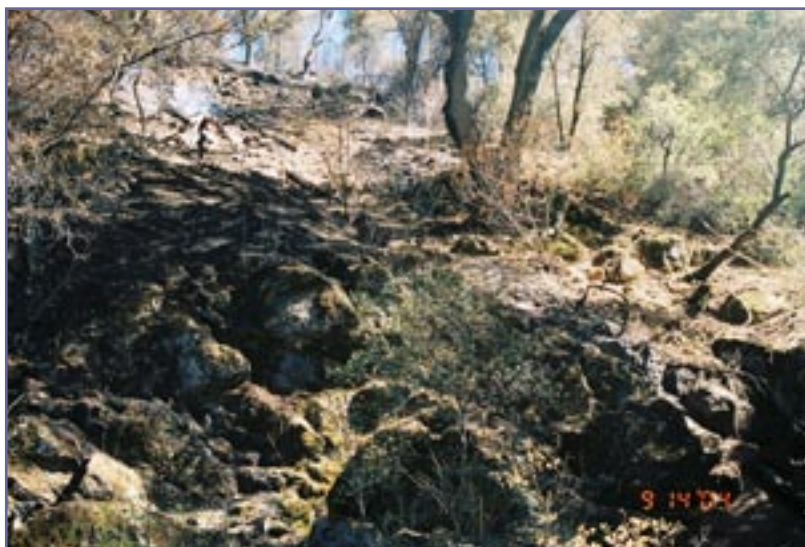
Burn indicators including cupping on low lying brush, protection indicators on and around rocks, degree of burn and leaf freeze showed that on the lower one quarter of the slope below the road, a slow burning backing fire continued to burn cross-slope towards the accident site. Burned fuels indicated that prior to reaching the general accident site the backing fire moved into a stand of low oak trees and brush with openings covered by more continuous leaf litter and pine needles. This increased continuity in fuels from sparse grass to leaf litter allowed the fire lower on the slope to continue its spread south.

*Photo H-7.
View from
mid-slope, up-
canyon of the
fireline.
This is the
area into
which Helitack
Captain Winger
and Firefighter
Andahl ran
before turning
downhill. Ash
remains show
increased fuel
loading in the
area.*

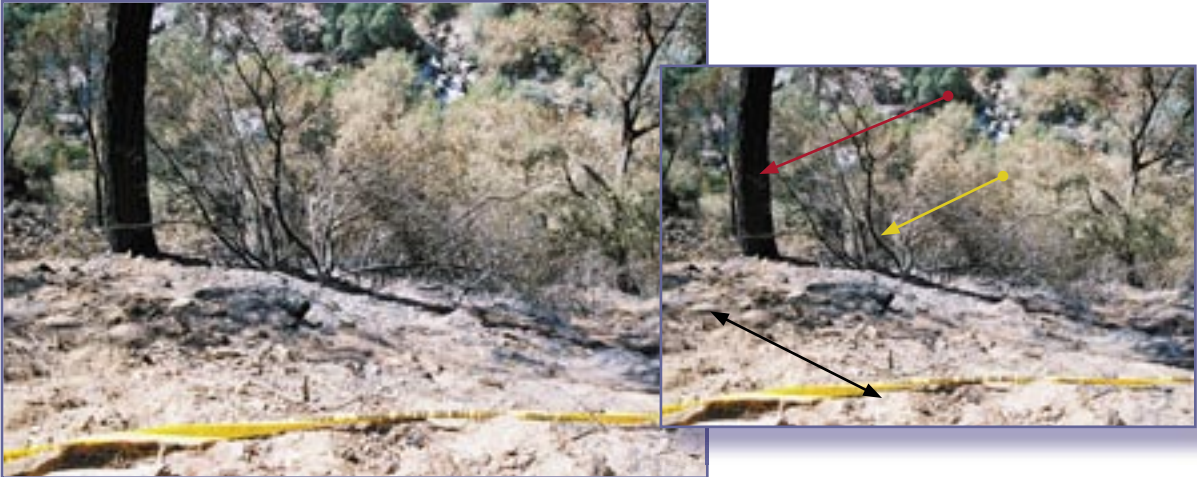
Near the lower one-quarter of the slope and outside of the proposed line location but within the accident site, the remains of a moderate sized downed oak tree with three trunks was lying up and down the slope. Near the top of the line location on the fire side, the ground appeared to have moderate leaf litter fuels with some dead and down brush and tree branches. About 25 feet below the road and on the fire side of the line was a mature gray pine. Next to this gray pine, toward the fire side and slightly downhill, was a single toyon bush.

Photo H-8. View from road at top of line construction (black arrow) down-slope towards gray pine (red arrow) and toyon bush (yellow arrow) which are located at bottom edge of fired out area and at upper edge of brush patch which sustained fire run.

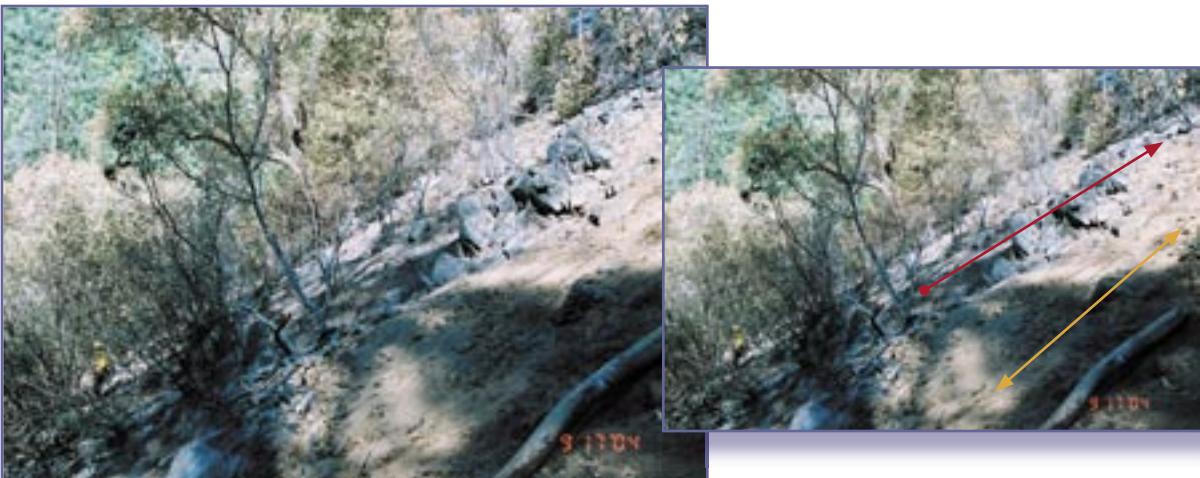
Below the toyon bush and gray pine and inside the proposed line location was a moderately heavy patch of mixed toyon and live oak brush which covered an area about 45 feet up and down the hill and 28 to 30 feet across the hillside. Below this brush patch the undergrowth turns to scattered live oak brush, toyon and oak trees with leaf litter and some downed limbs. Below this initial transition from the brush patch, the area opens up to patchy brush, oaks and leaf litter.

Photo H-9. View of lower end of brush patch showing beginning of run (red arrow) in brush up-slope. Constructed handline (yellow arrow) located in right lower corner.

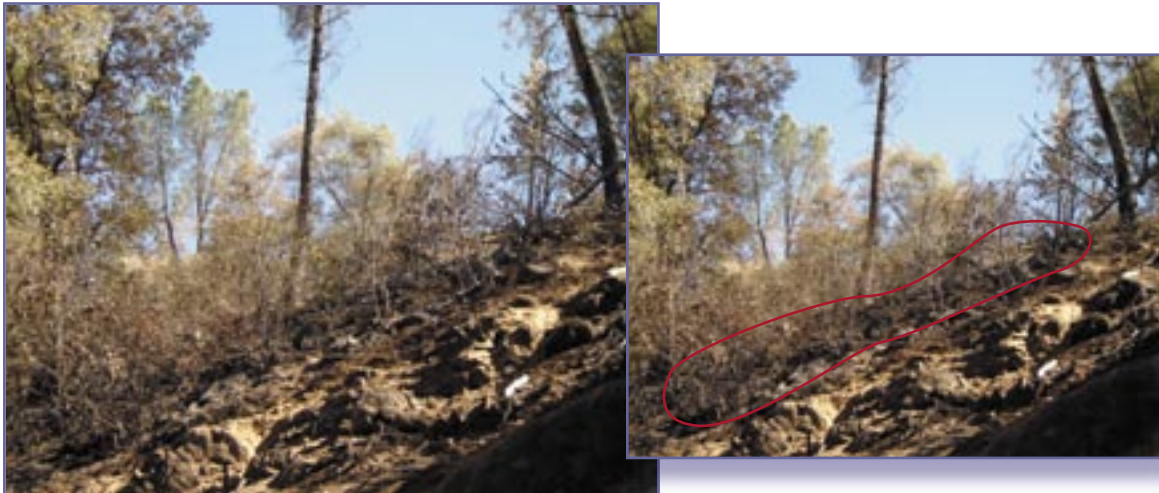
Photo H-10. View of brush patch (red line) which burned off just inside line location directing convective heat towards the upper end of the line near the road.

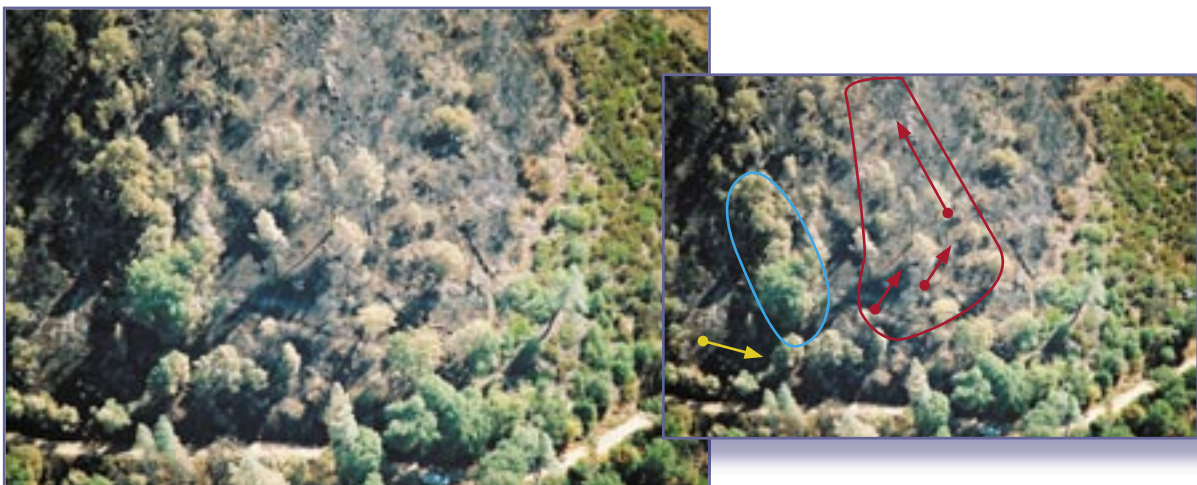
At the same time the fire was spreading cross-slope below the road, fire had established itself above the road and spread into a standing snag about 80 feet tall. The snag was located about 30 feet to the north of the proposed line location, about 40 feet up-slope of the road. This snag was observed just prior to the accident by a member of Engine 43 to have been burning about 40 feet up.

Photo H-11. View of area above the road and above accident site. Green trees visible to the left edge of photo above road is area of possible helicopter water drops (blue line). In center of photo is area which burned hot (red line) and rapidly (spread direction shown in red arrows) prior to and during accident events. Burning snag (yellow arrow) was located below and to the left of bright green tree above road in lower left corner of photo.

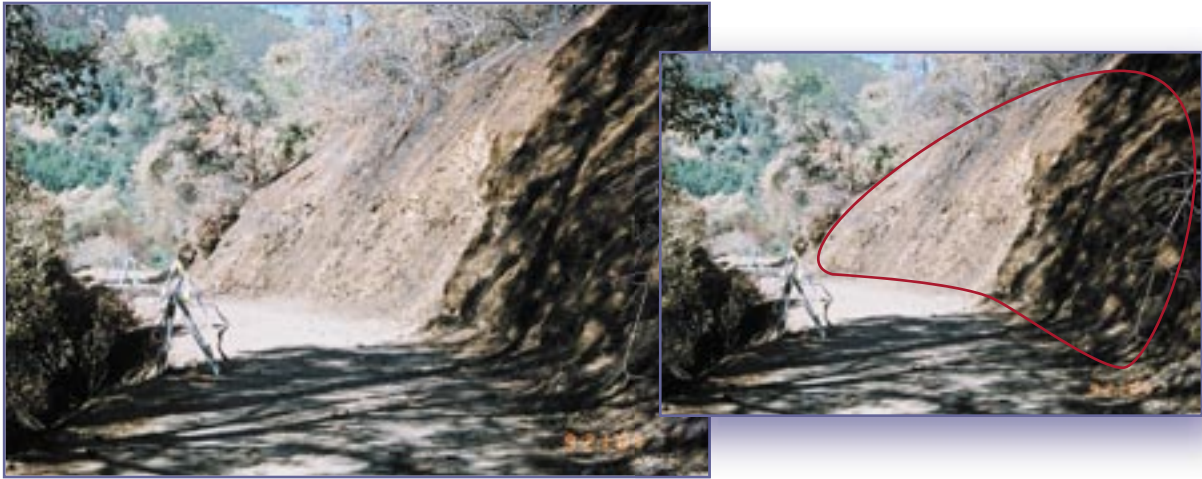
The slope above the road and accident site was more open than below the road. The steep cut bank and initial fuels along the top edge of the cut bank restricted visibility from the road up-slope. Several members of the Helitack crew and crewmembers of Engine 43 confirmed this restricted visibility.

Photo H-12. View from south to north along Lumsden Road, above accident site, showing steepness of cut bank above road and area burned by spot fire (red line) on cut bank.

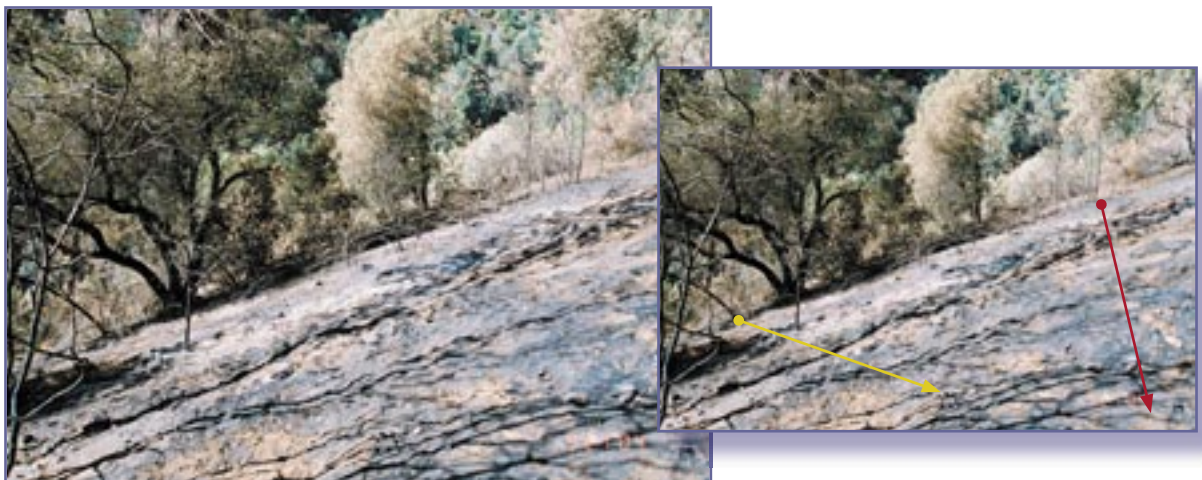
On the up-slope side of the road and toward the north, a line of low, burned fuels indicates the location of possible helicopter water drops made by Copter 404 (See Photo H-11, page 140). A number of burn patterns are present to indicate that a low-intensity fire burned cross-slope and through this area in several locations. Side-slope and to the south of this area the fire established itself in a pocket of heavy brush and surface fuels. The source of the spread of this fire could not be conclusively determined but strong evidence indicated it to be lateral spread across the slope from the north. A possible spot fire generated by a hot ember dropping from the burning snag nearby cannot be supported due to the distance and noted wind speeds but cannot be ruled out as a result of rotor wash.

Photo H-13. Area above the road in which the fire had established itself prior to accident events. Fire spread indicators show fire coming from right of photo and burning hot in upper right corner of photo before moving up-slope toward where photo is taken (red arrow). Spot fire from cut bank spread up-slope (yellow arrow) and joined this fire from lower left of photo.

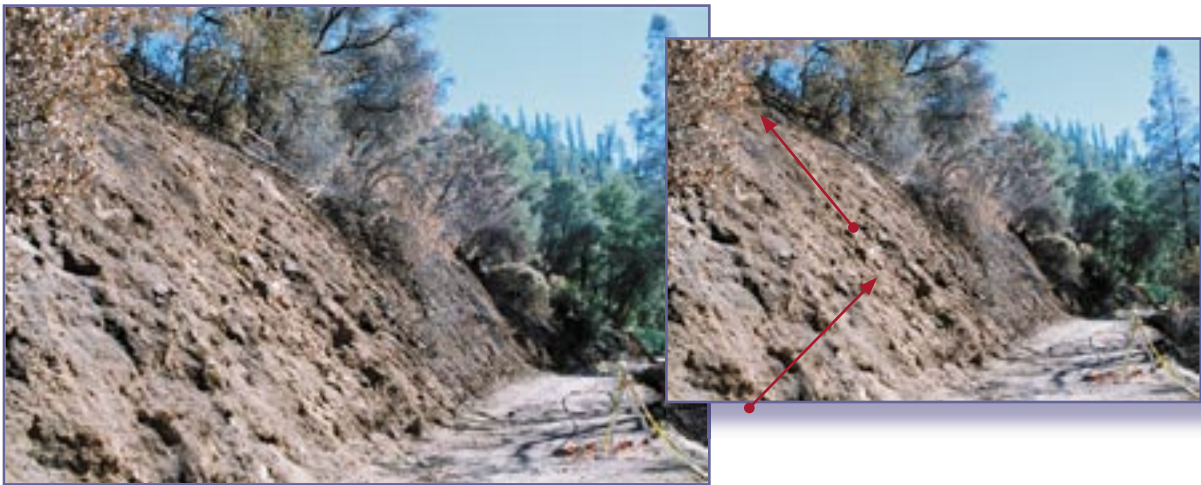
Macro and micro burn indicators show that in the area above the road and to the north of where the spot fire had turned up-slope, an advancing fire front had already established itself from the fire that had burned cross-slope. This fire was extremely hot and spread in grass, leaf litter and brush over an area about one-quarter acre in size. Scorch heights on gray pines were observed to be 80 feet and higher along with consistent needle freeze above that level. Brush consumption in this area was more complete than in most other areas on the west aspect. Burn indicators in this area show that this fire was burning with a wind that was opposite the direction that the winds had been burning below the road prior to the fire run and with the slope in a southeasterly direction. The lateral spread of this fire was joined by the spot fire from the cut bank above the location where Captain Mount observed the spot fire to turn uphill. This fire spread from the west aspect above the road up-slope to the southeast towards the lower levels of the south slope in Drew Creek. Burn indicators show that this fire rounded the ridge dividing the west aspect above the accident site and the south aspect in Drew Creek and turned up-slope to the east.

Photo H-14. View from north to south along Lumsden Road above the accident site from next to the top of the line construction and near the reported location where the spot fire was located. Spot fire spread along slope (red arrows) away from camera and then turned up-slope.

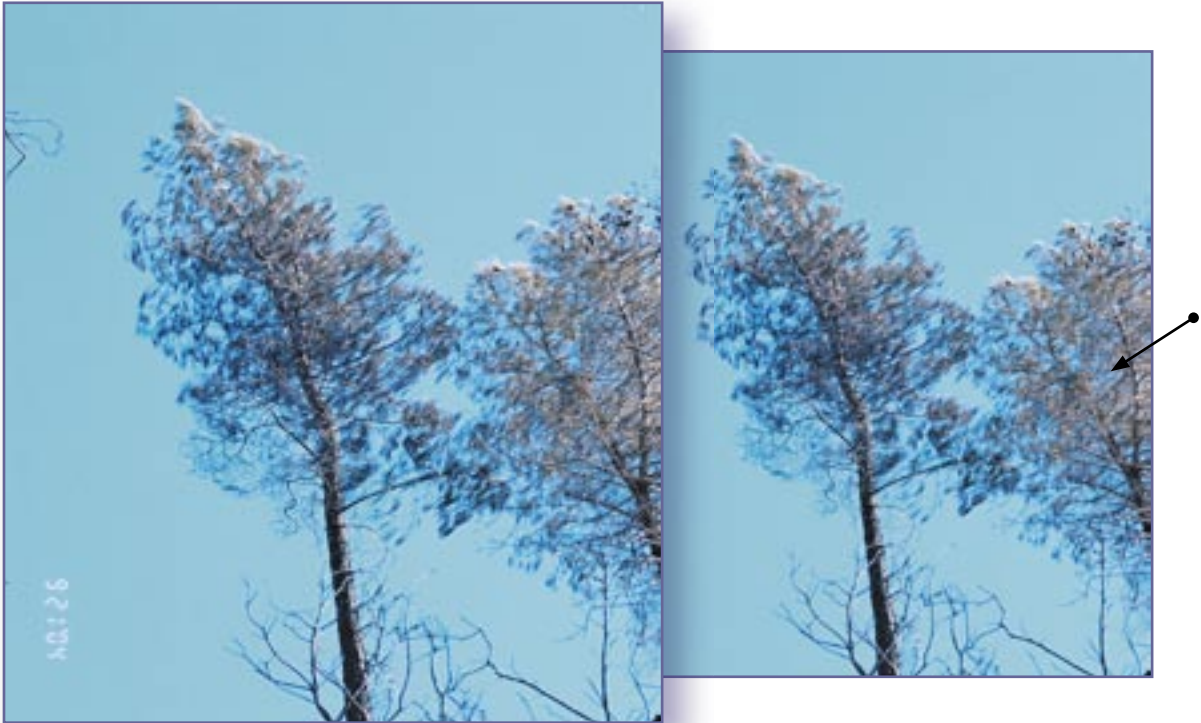
Photo H-15. Gray pine located along dividing ridge between Drew Creek south aspect and accident site west aspect slopes. Needle freeze (black arrow) and scorch height on pines indicates severe burning activity and wind directions curling from the west aspect up-slope and east, turning up-slope and to the north on the south aspect. Photo taken looking generally west to east.

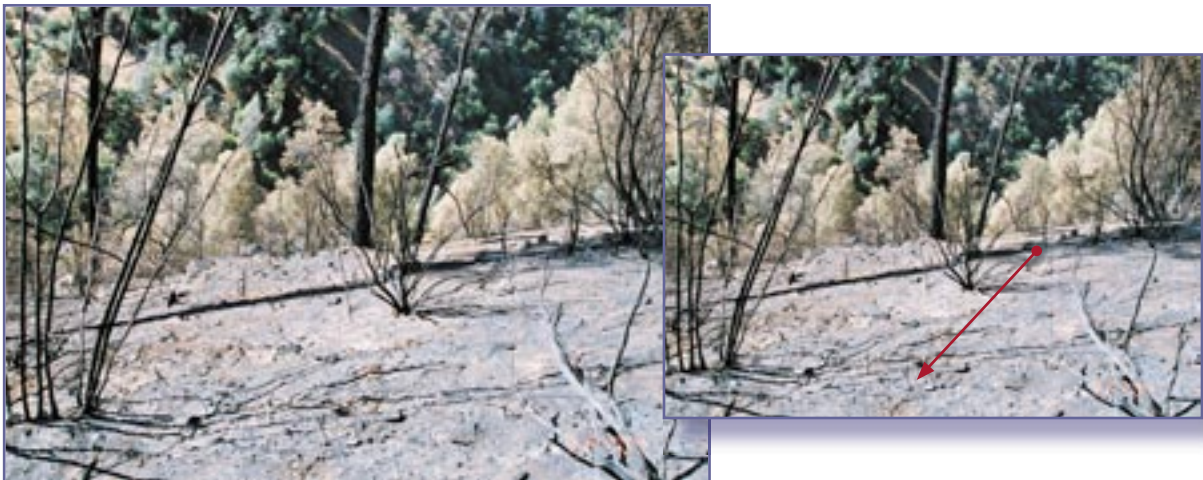
Photo H-16. Photo is taken near ridge separating west slope and north slope above the road and accident site. Photo shows route that fire traveled (red arrow) and the degree of burn.

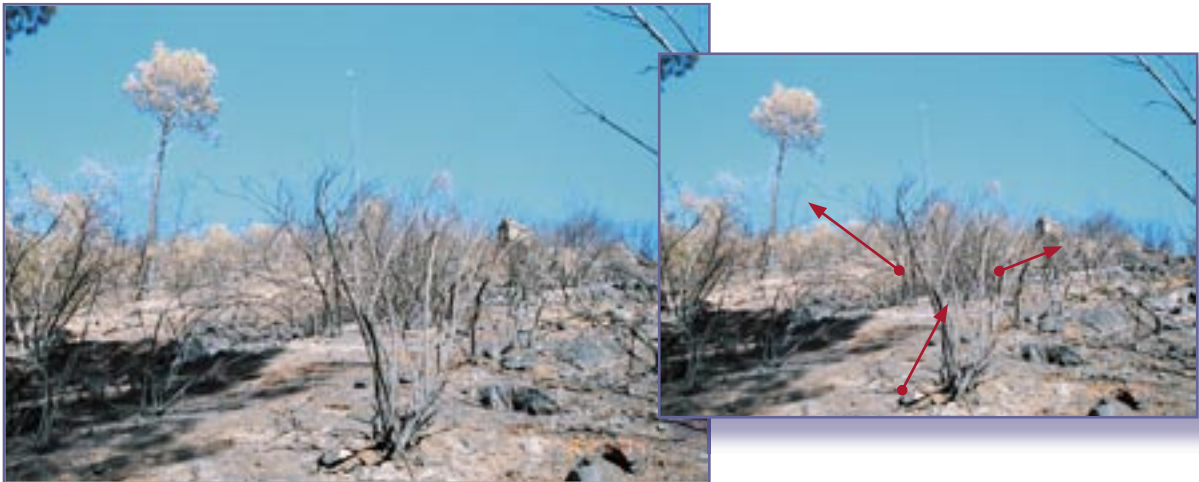
Photo H-17. Photo taken from ridge above road and accident site, which separates the west slope and the south slope. View is up-slope with west slope to left and south slope to right. Photo shows path where fire turned up-slope/ridge (red arrows) and degree of burn. Pine tree in upper left corner shows needle freeze indicators of fire coming up-slope from this location towards it. Fuels changed in this location from leaf and needle litter with patches of brush to consistent chamise brush field to right of photo.

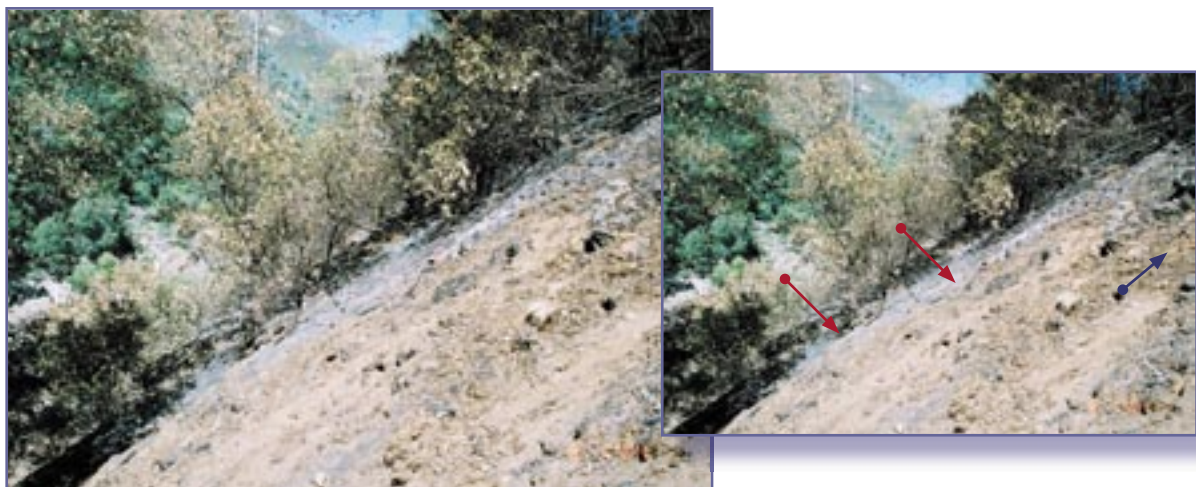
At the same time as the fire activity on the cut bank above the road, the fire below the road, which had been backing cross-slope and into the wind on the lower quarter of the slope, made a rapid run cross-slope to the south and up-slope. This fire spread directly toward the lower four members of the Helitack 404 crew. Burn indicators show that this fire spread remained initially in the surface fuels and moved rapidly under the brush present in scattered locations in this area.

Photo H-18. View from lower third of slope below the road at accident site looking from south to north cross-slope towards the direction where Helitack Captain Winger indicated the fire run had come from (red arrows). Chain saw work visible on right edge of photo and near center of photo (blue arrow).

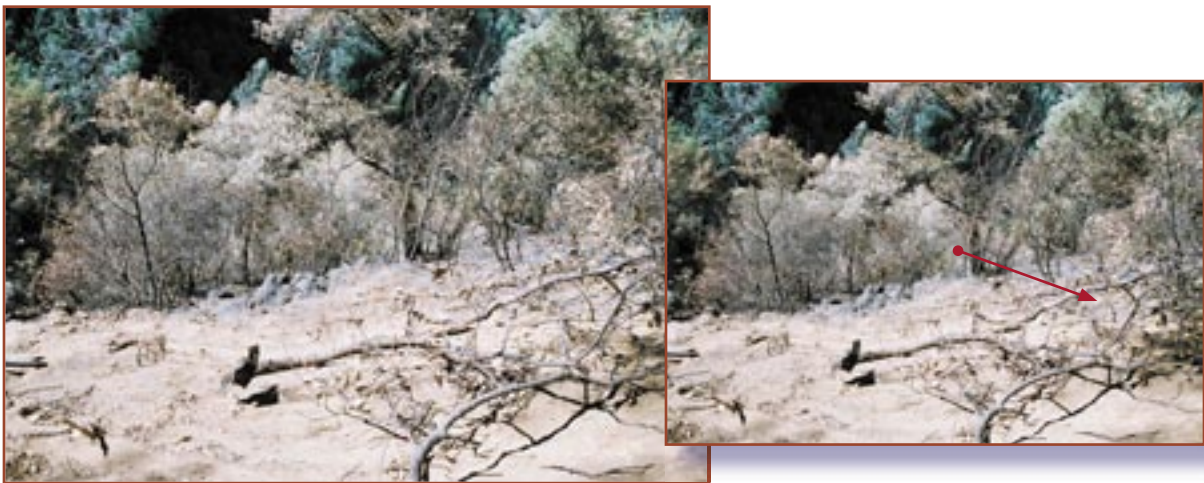
As the fire on the lower one-quarter of the slope below the road reached the bottom of the mixed brush patch of toyon and live oak approximately 28 feet inside the line location, burn indicators show that intensity, slope and fuel continuity (both surface and brush) provided enough heat to lift the fire into the brush itself. The consistent up-slope, and slightly to the south (right), burn pattern shows a rapid and hot torching run of this brush patch (45 feet up-slope) with most of the heat vectoring up-slope to the right and across the upper portions of the line construction where two members of the Helitack 404 crew were attempting to escape up-slope to the road.

Photo H-19. View from line location down-slope with brush patch visible to center and right of photo. Fire spread up-slope (red arrow) toward the location from which the photograph was taken and from the downhill right center of photo.

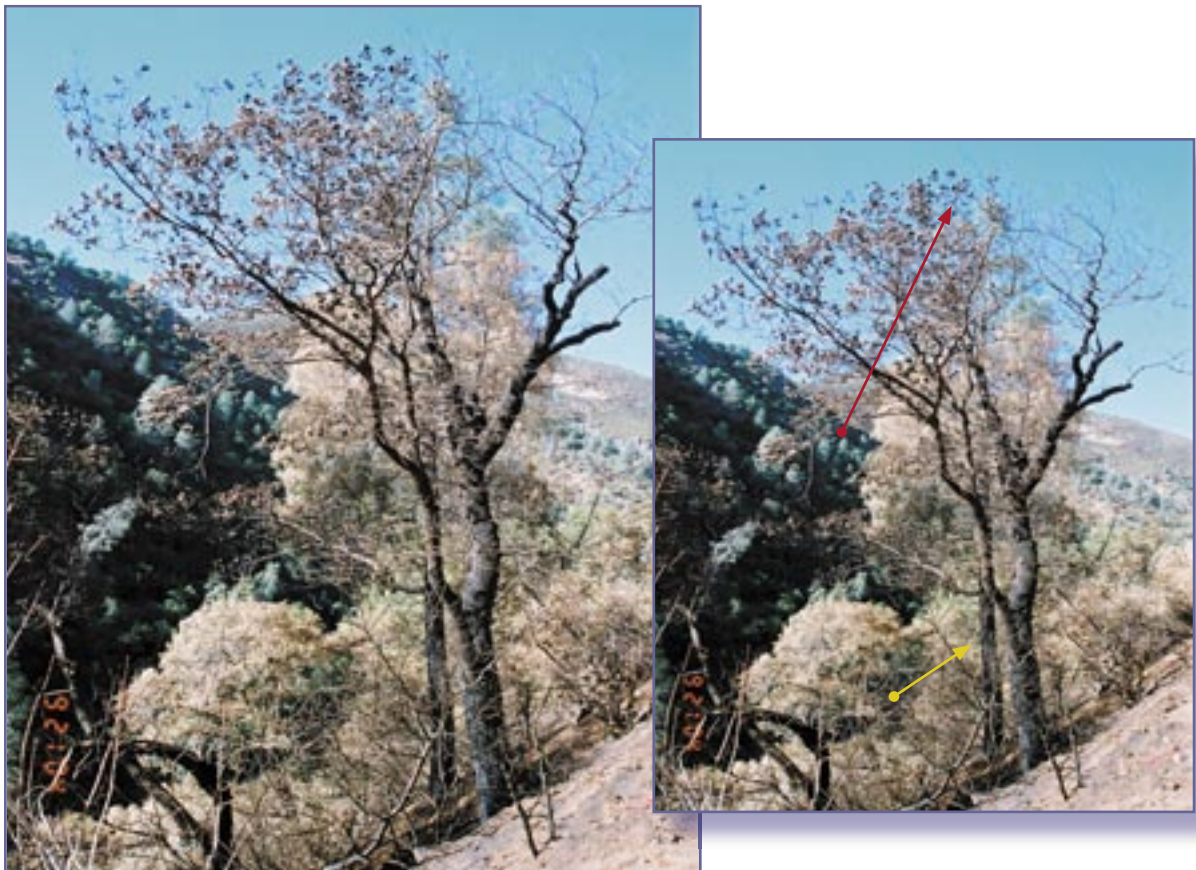
Photo H-21. View of oak tree with leaf freeze indicators (red arrow) showing fire spreading up-slope to road in accident site. Oak is located about 30 feet south of where line left road. Gray pine (yellow arrow) about 25 feet below top of constructed fire line is seen behind the oak tree.

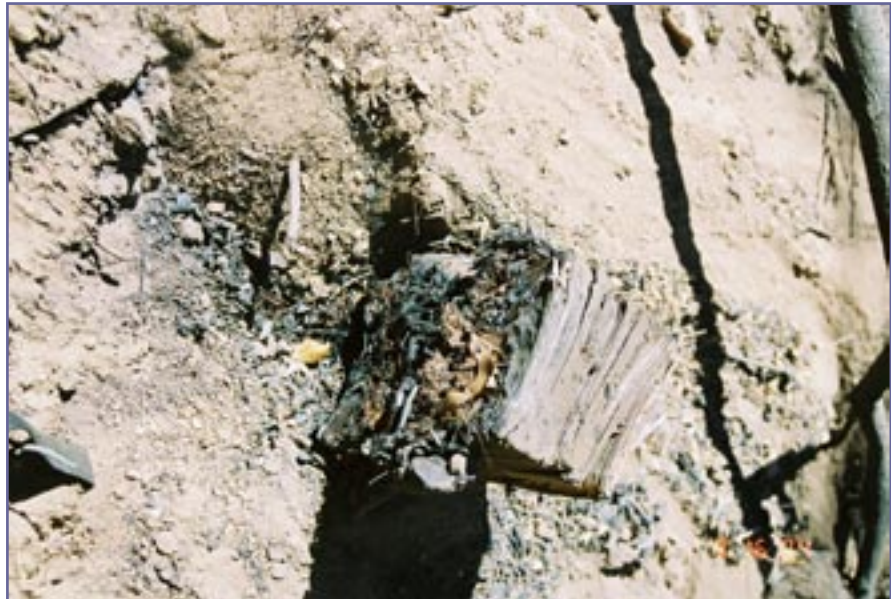
Photo H-23. Photo of unburned vegetation located under loose rock about 2.5 feet up-slope from body recovery site, indicating that this area was not burned at time rock slid to this location.

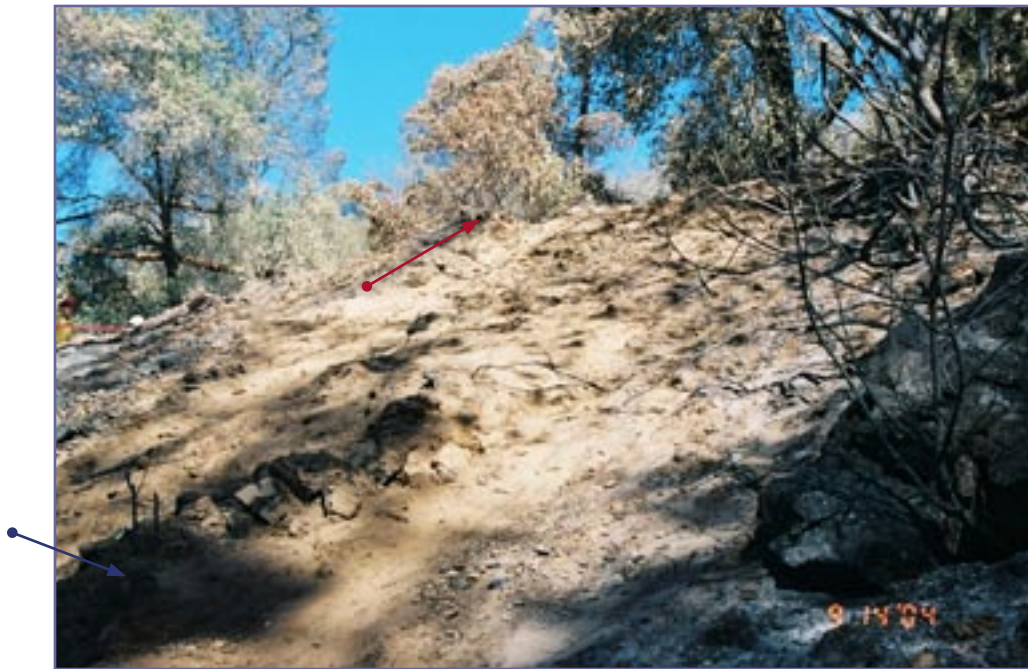
Photo H-24. Burned debris associated with Firefighter Schicke highest on slope located in lower left corner of photo (blue arrow). Road (red arrow) shown 23 feet above at end of dirt slope.

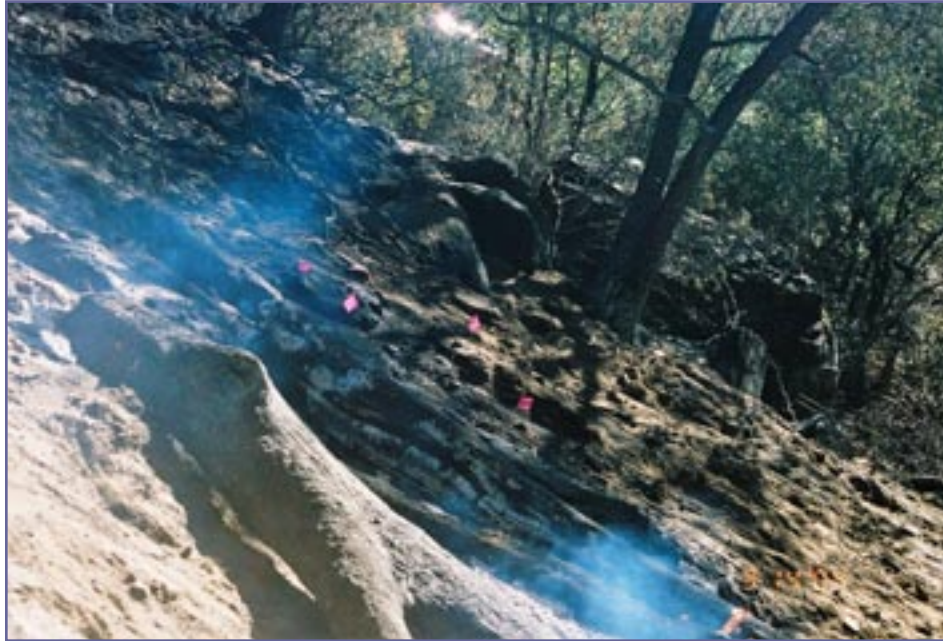
Photo H-25. Body recovery site (pink flags) below rock outcrop and side slope from heavy fuels.

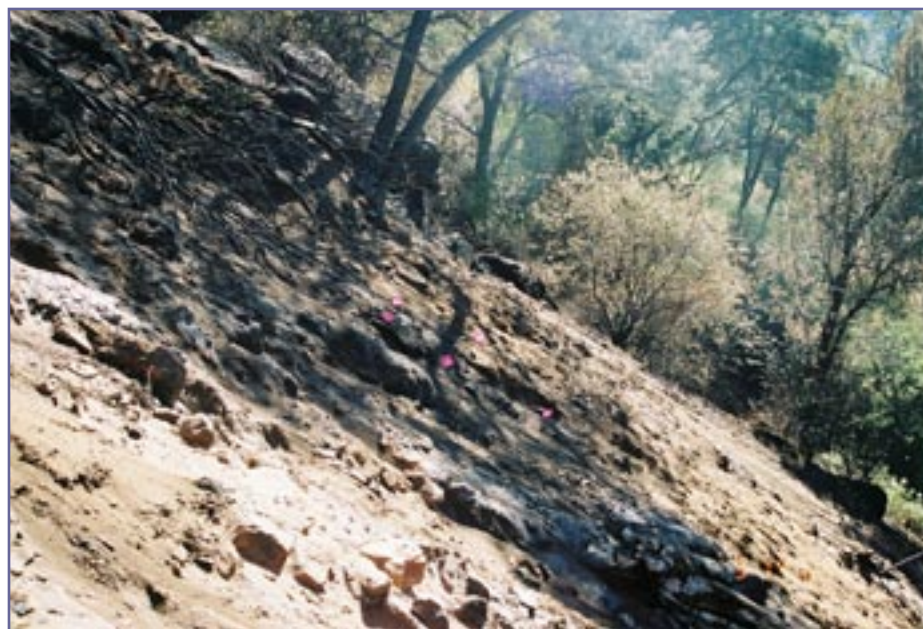
Photo H-26. Body recovery site (pink flags) from line location at rock outcrop looking down and side slope. Fire shelter recovered near center left edge of photo.

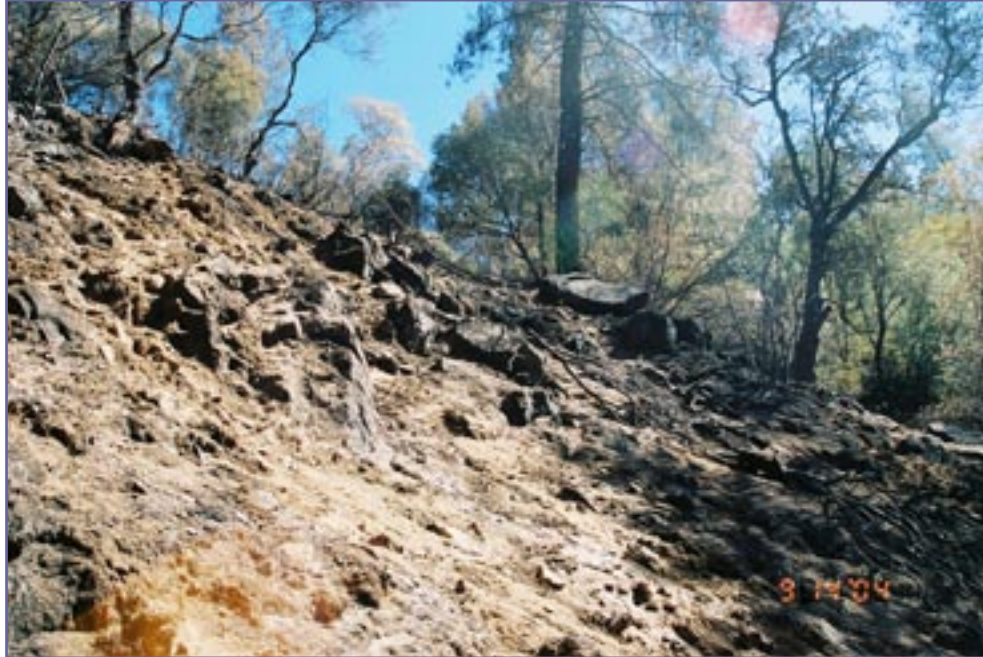
Photo H-27. View up-slope and from line location showing rock outcrop, located above body recovery site that line passed over.
