Accident Investigation Report

CDF HELITACK CREW 404 BURNOVER

Tuolumne Fire
CA-STF-2191
Stanislaus National Forest
September 12, 2004

CDF Helitack Crew 404 Burnover Accident Investigation Report

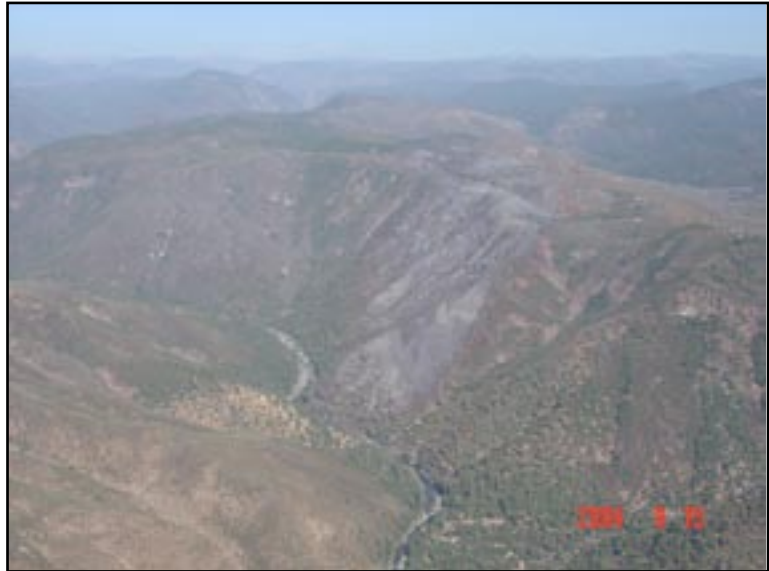
Overview of
Tuolumne
River Canyon
looking East.
Fire and accident
site is in lower
center of photo.

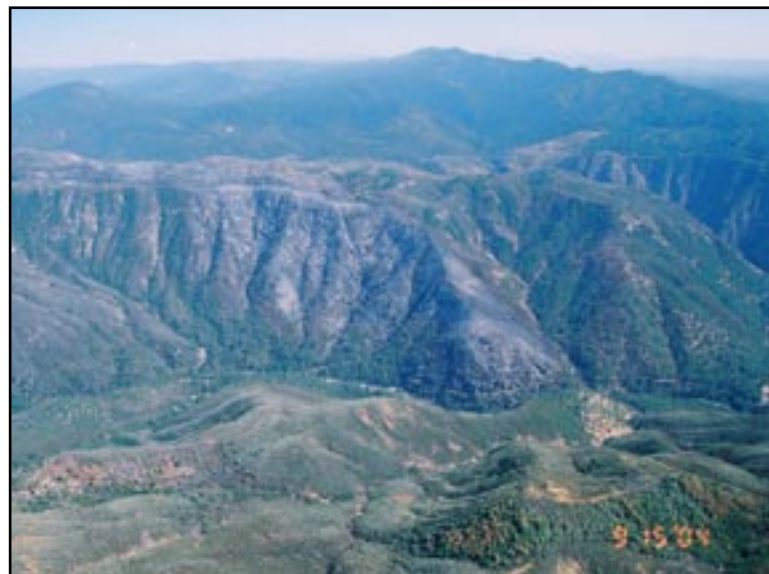
Tuolumne River
Canyon looking South.
Fire and accident
site is in center of photo.

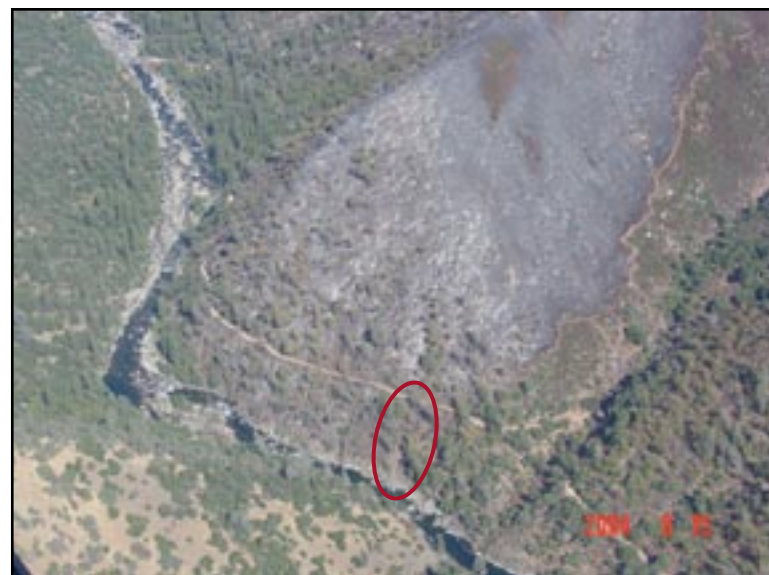
Tuolumne River, fire
origin, accident
site (red oval).
Lumsden Bridge
is at top of photo.

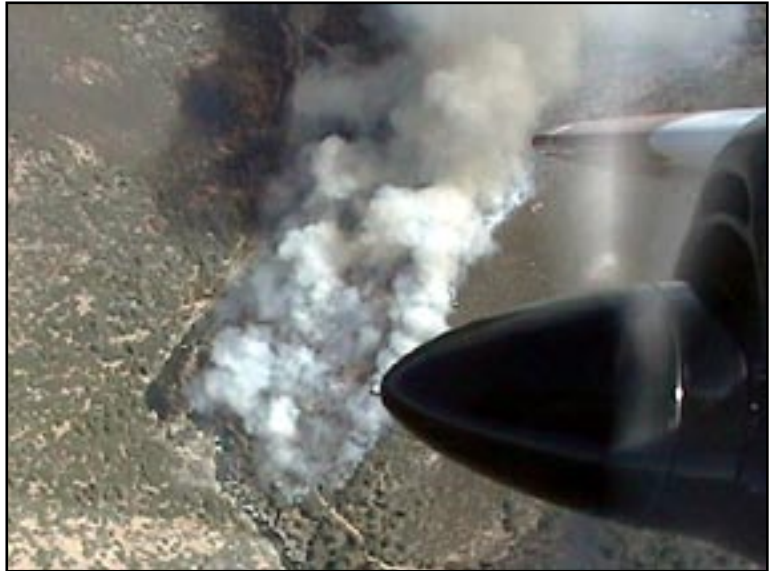
Fire upon arrival of Air Attack 440.

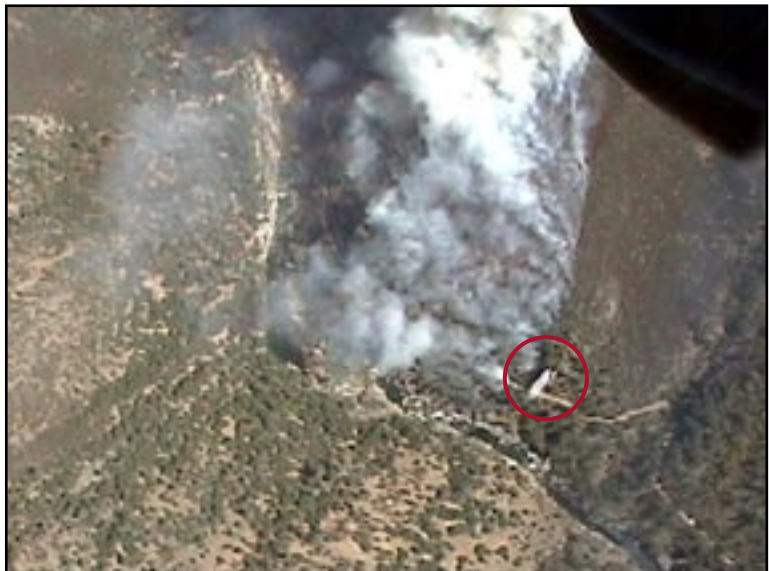
Copter 404 (in red circle) first drop (above Lumsden Road).

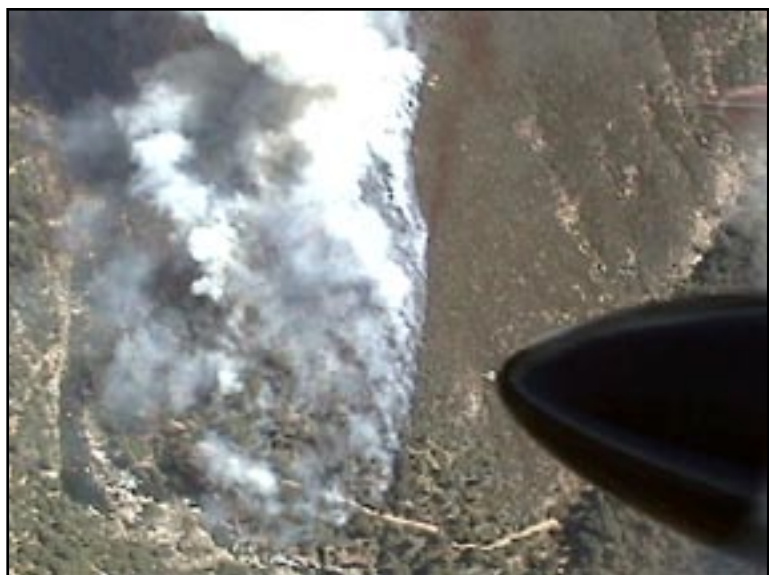
Retardant drops (red/brown streak on hillside on right flank).

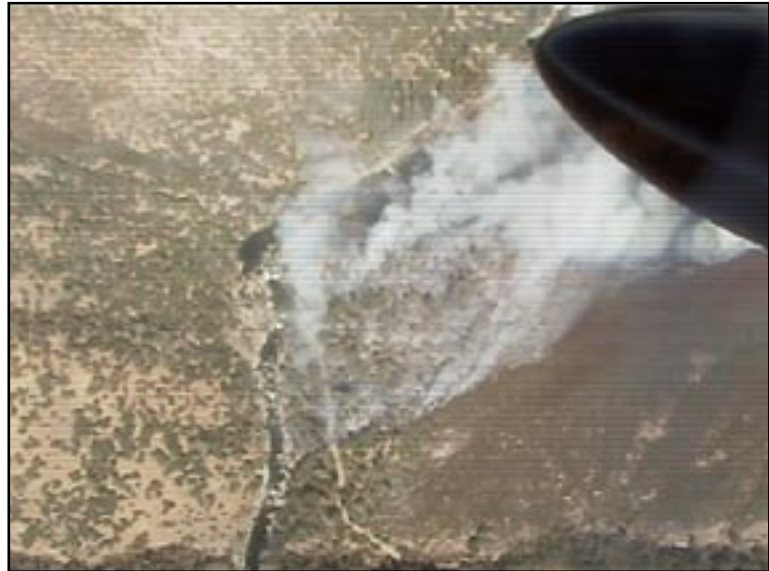
Wind and smoke drift prior to flare-up.

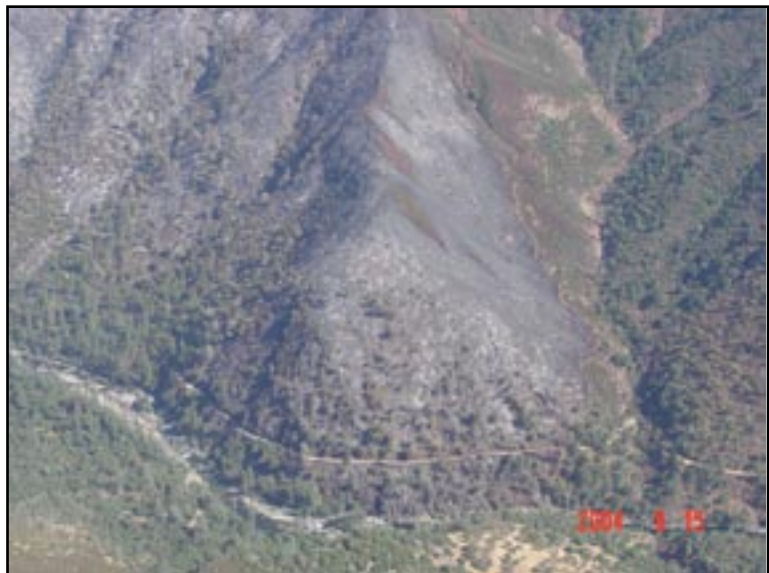
Fire origin along Lumsden Road (parallel to the river).

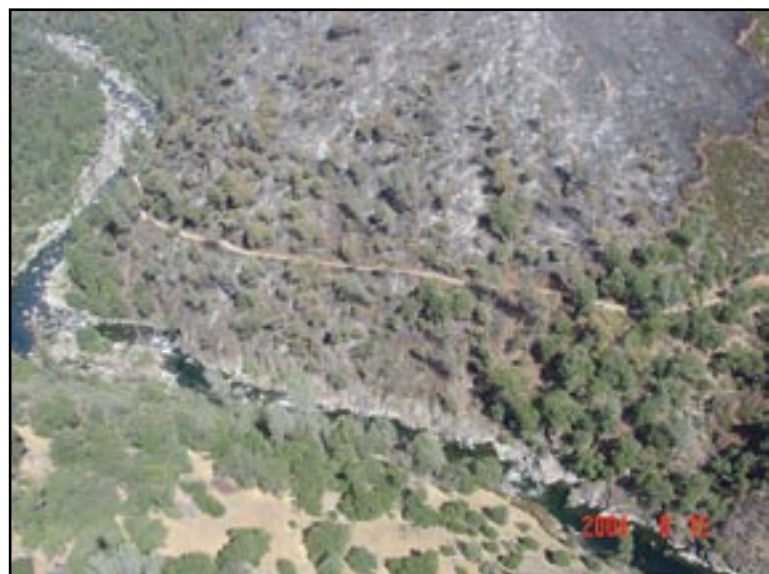
Rocky river bank and steep slopes below the road.

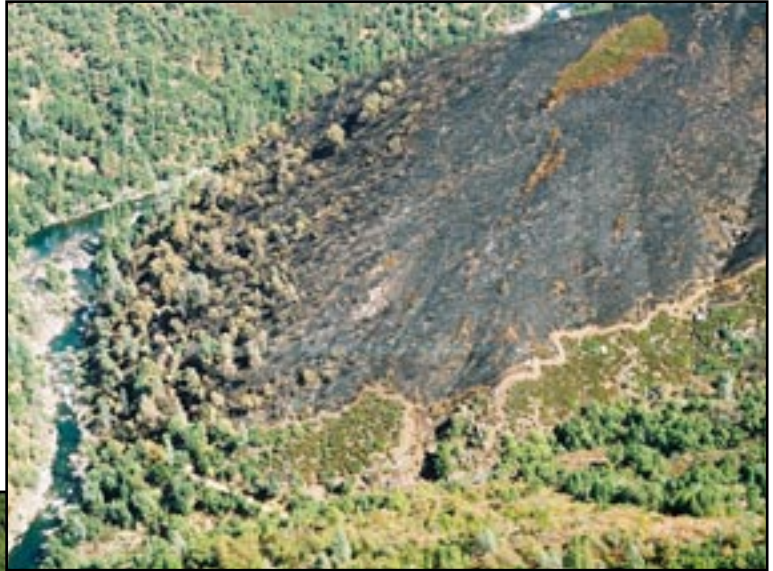
*Right flank of fire.
Drew Canyon is at
bottom of photo.*

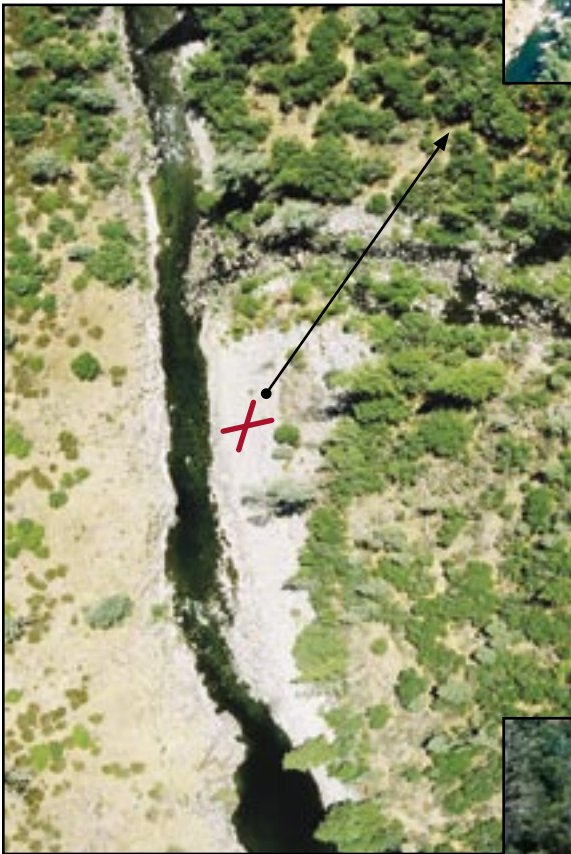
The seven firefighters from Copter 404 hiked to Lumsden road (black arrow shows walkout route) after being dropped off on gravel bar landing zone (red "x").

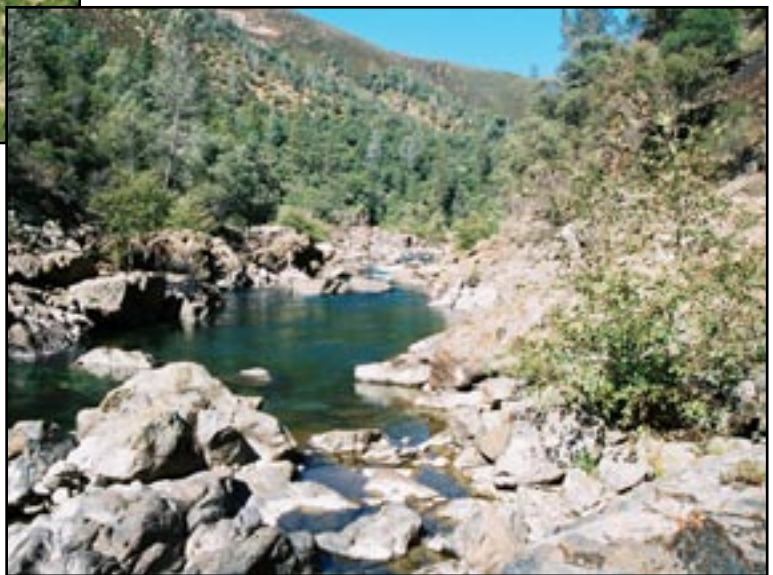
*River bank immediately
upstream from copter LZ.*

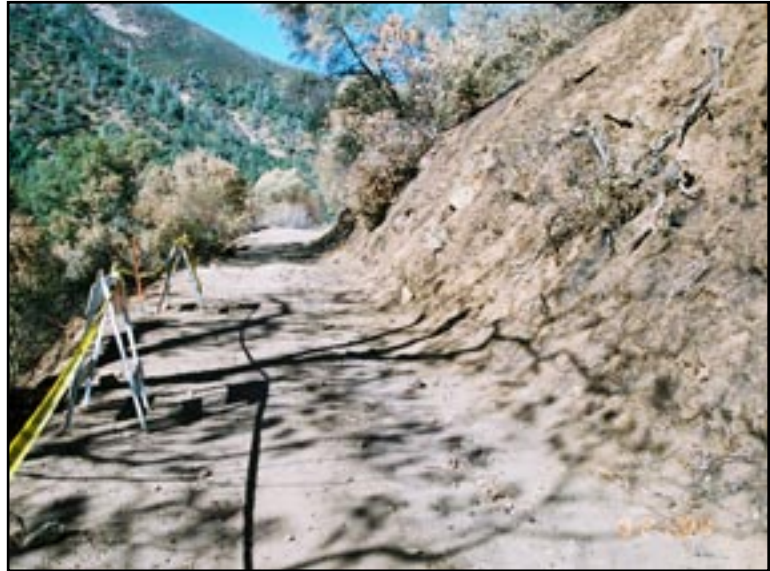
Lumsden Road looking east from accident site.

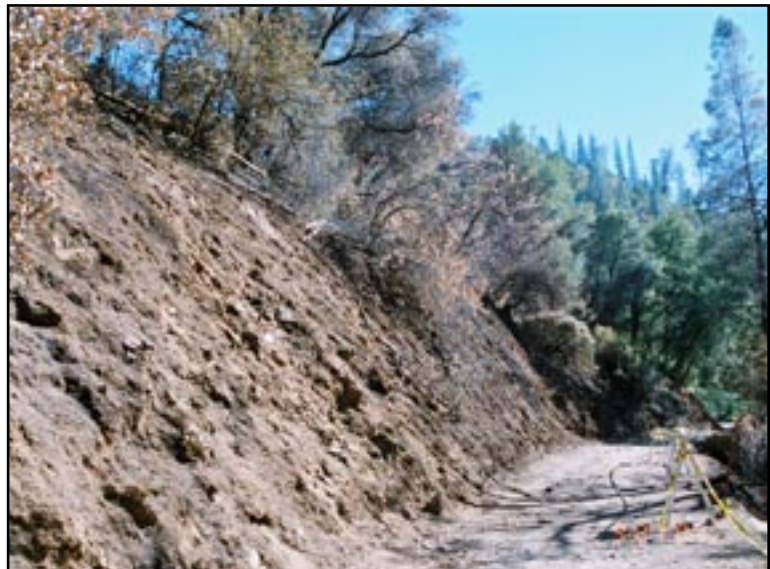
Lumsden Road looking west from fireline anchor point. Line construction is to the right at the orange flagging.

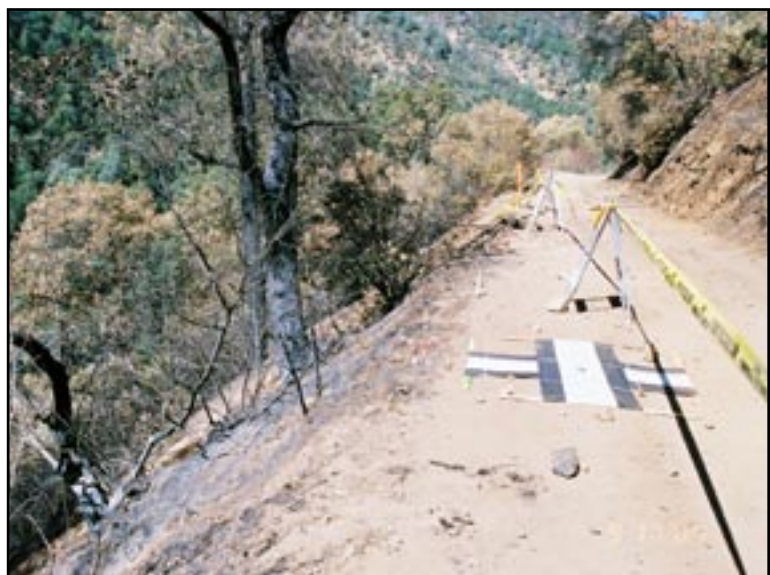
Lumsden Road looking east. Fire line anchor point is at orange stake just past second sign. Constructed fireline is downhill from the road.

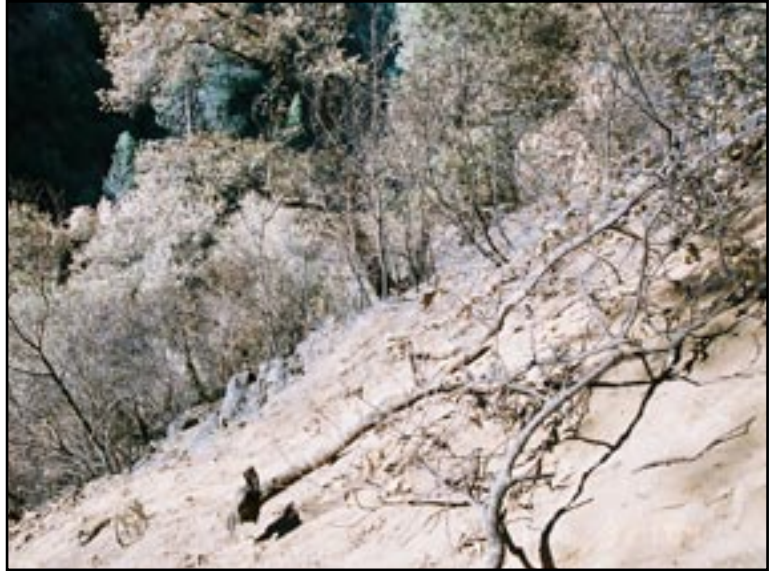
*Fireline construction area.
Lumsden Road is to right
of photo. Rock outcropping
is in center of photo.*

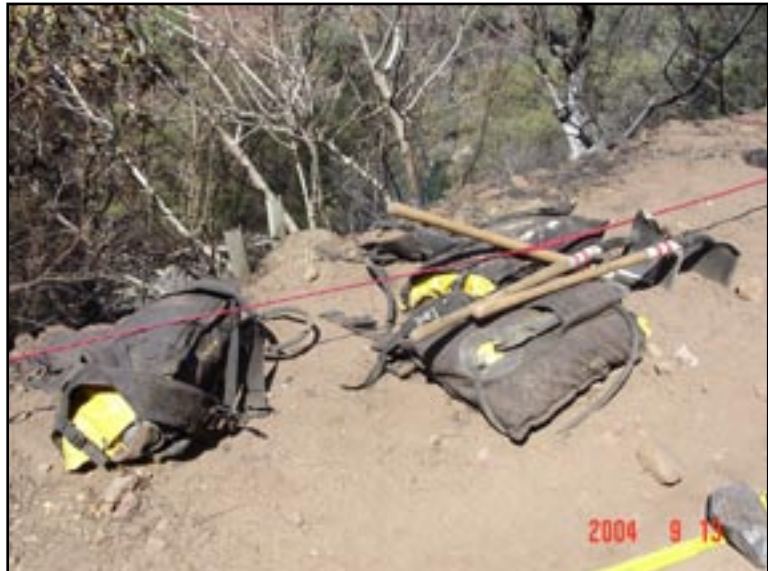
*Backpumps and
scraping tools
staged at
the road edge.*

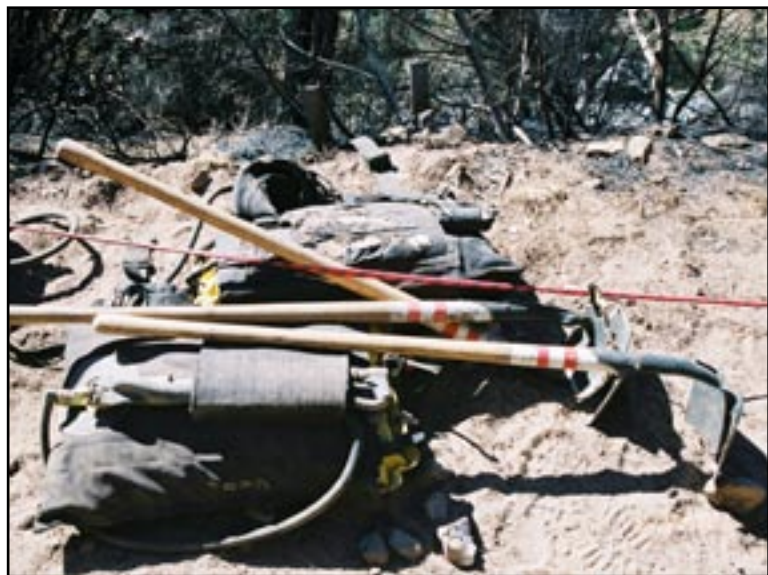
*Bladder style back
pumps and "Rhyno"
scraping tools.*

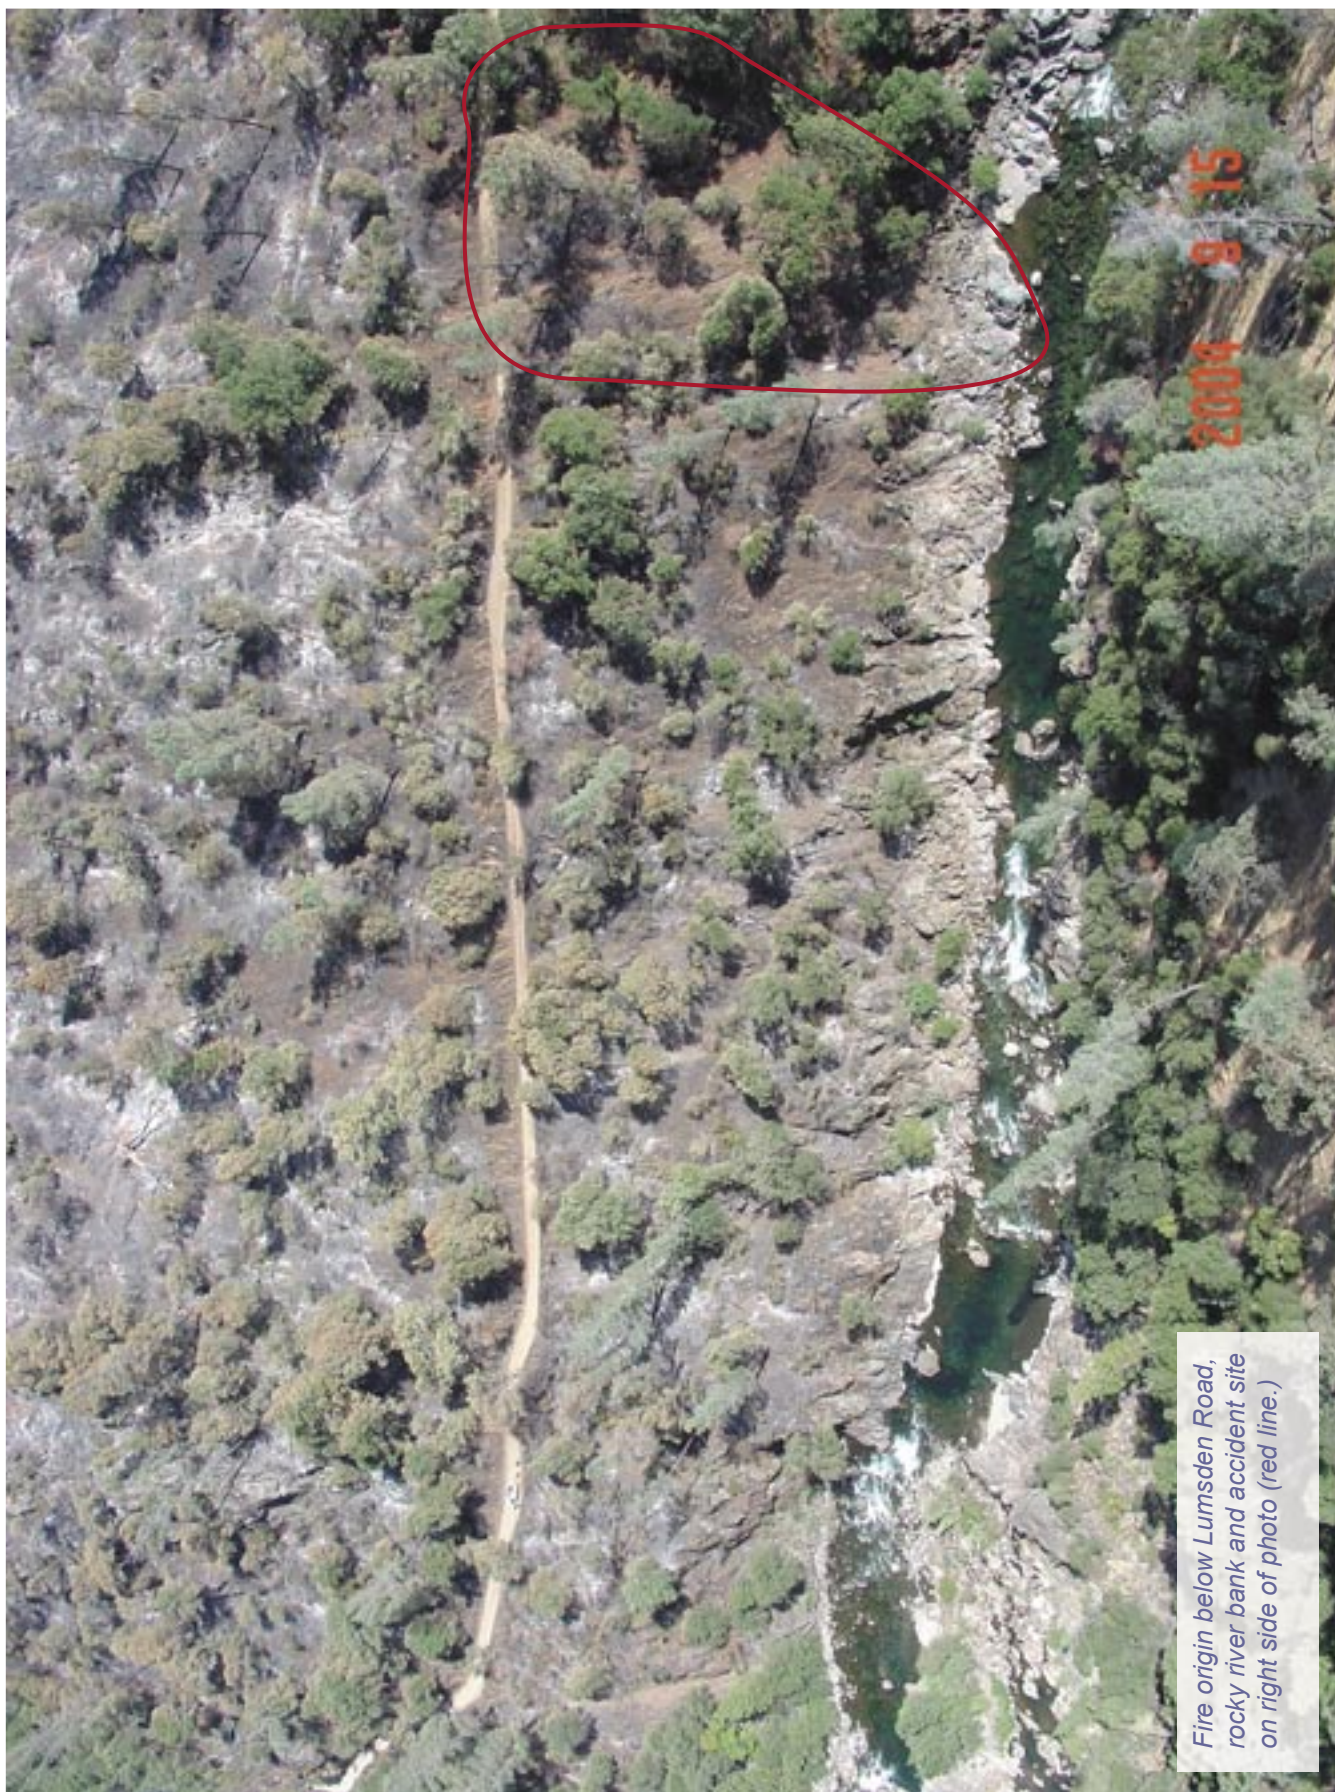
Fire origin below Lumsden Road, rocky river bank and accident site on right side of photo (red line.)

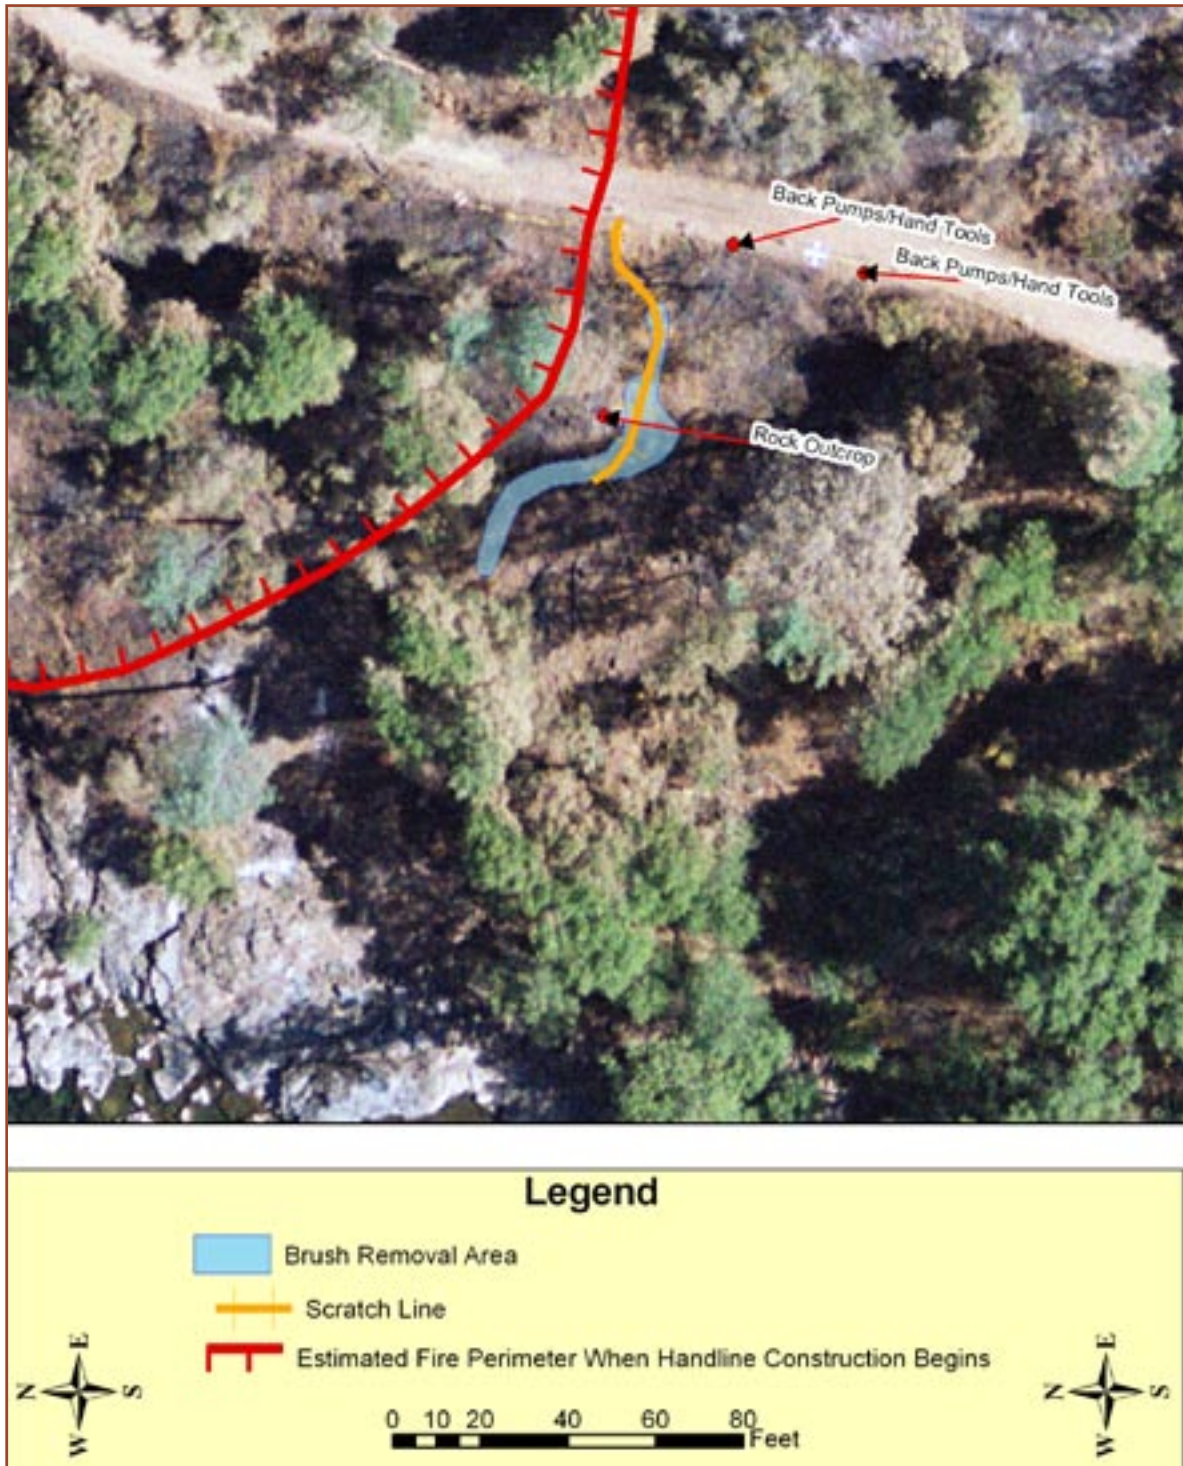
Fire Line Construction Prior to Flareup

- The short distance of unburned fuel between the fire's edge and the fireline allowed the fire to overrun the crew before they could utilize their escape routes in time. In addition, the burning fuel (particularly the brushy area below the road which presented a physical barrier) prevented the crew members from crossing the fire's edge into the black.
- Firing out of the unburned fuel from the road down was not sufficient to provide a safe fireline because it was incomplete. While firing out is an appropriate technique, not enough had been completed to be effective.

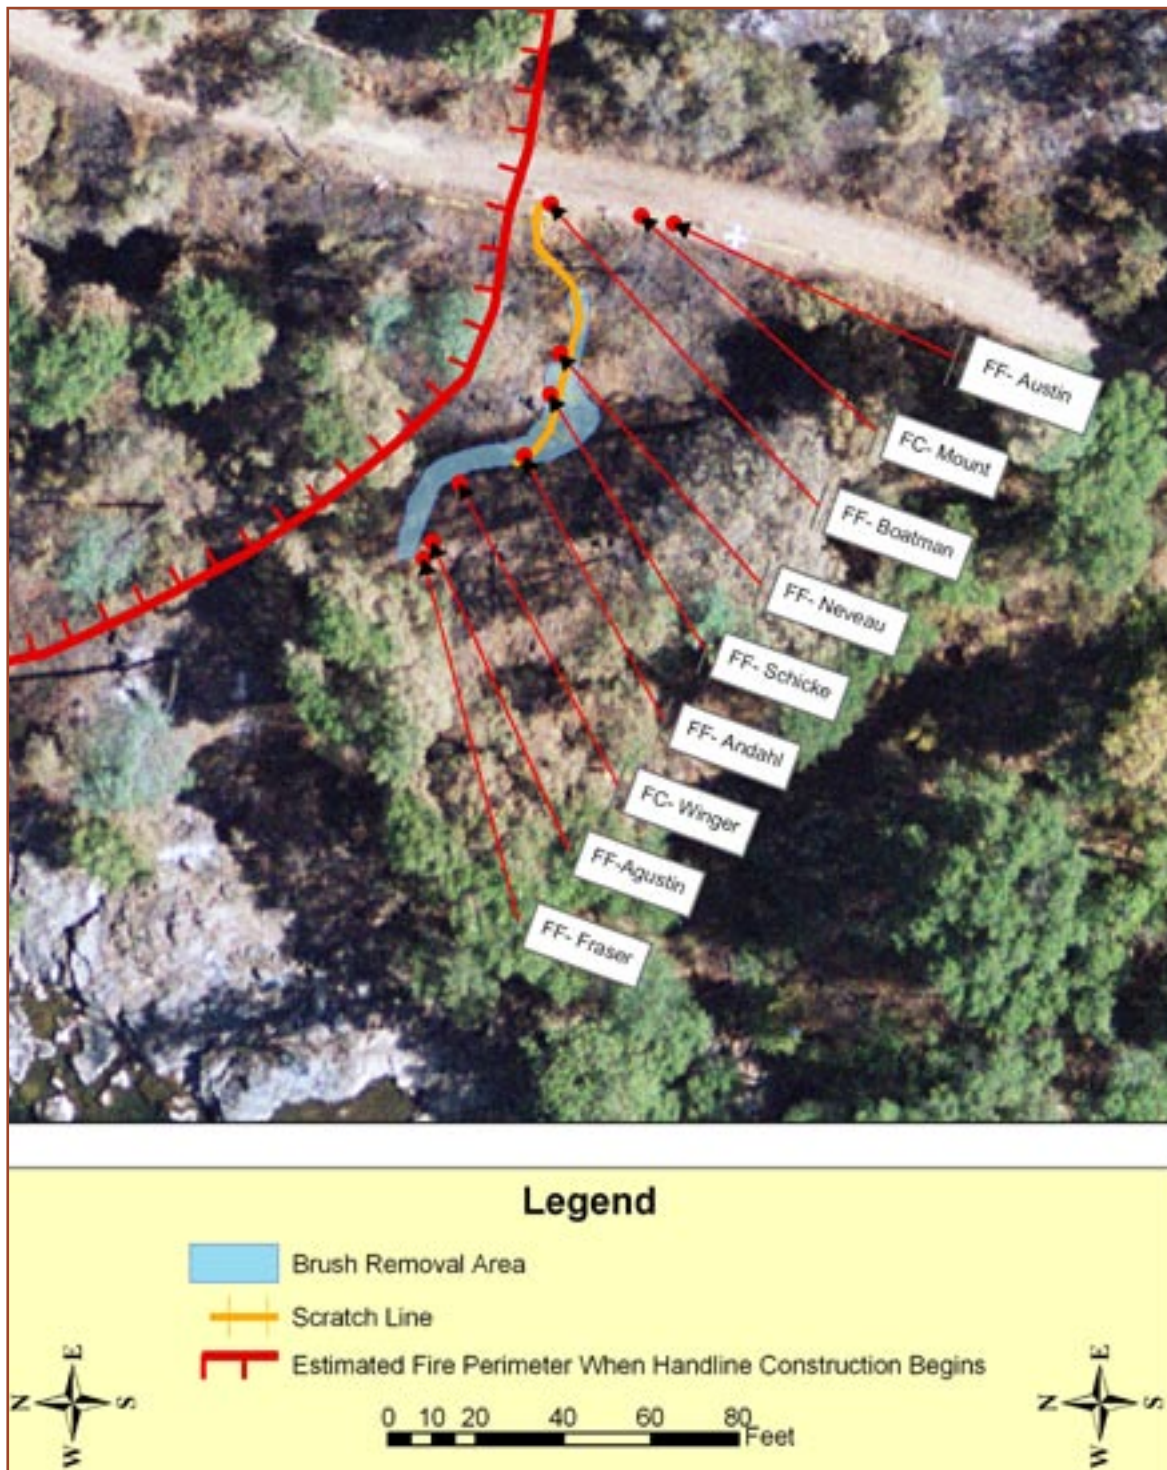
Personnel Location Prior to Flareup

- The steepness of the 80 to 120 percent slope combined with loose soil, rock out crops and drop offs made travel slow and difficult. This situation was a significant factor in the selection of the tactical options of downhill line construction.
- They did not consider withdrawing from the assignment.

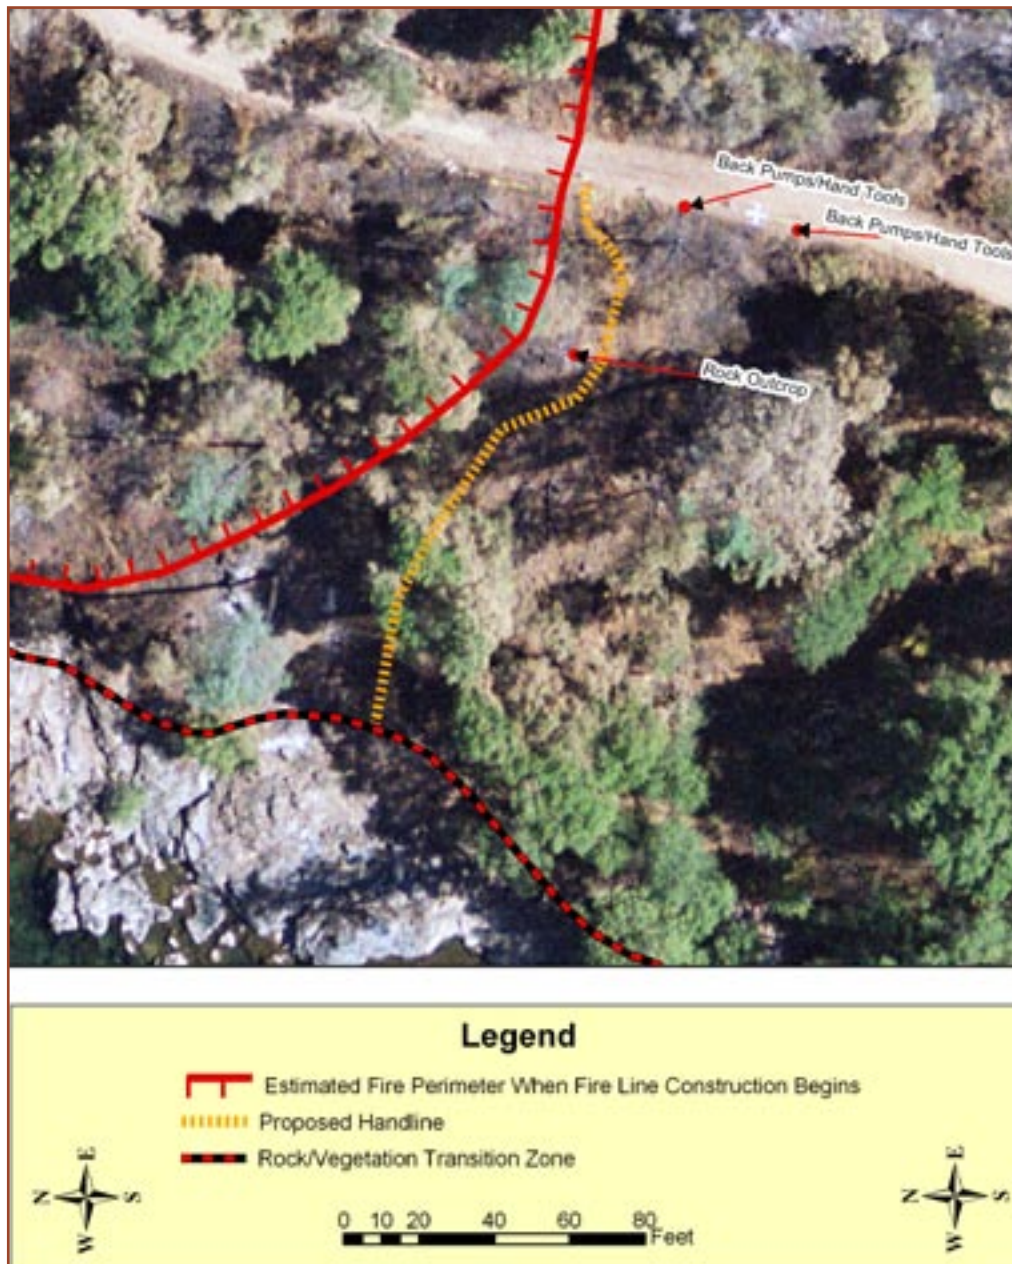
Planned Fireline Construction

Another tactic available was building direct fireline downhill. HC Winger characterized the fire as a “dirty burn.” HC Winger said that his concern was staying out of the residual heat and smoke from the dirty burn and the crew members would not be able to work from the black. There was the potential of a re-burn in the brush ladder fuels that would present a similar hazard as indirect line. They would need to use the back pumps on the steep slope. HC Winger decided that this tactic would take too much time and effort.

The tactic chosen was indirect downhill line construction parallel to the fire's edge. A reason given by HC Winger for going indirect was to keep the firefighters out of the heat and smoke of the dirty burn, take advantage of light fuels and they could fire it out as they went. They would not need to use the back pumps on the steep slope. He believed this method would allow them to build the fireline quickly.

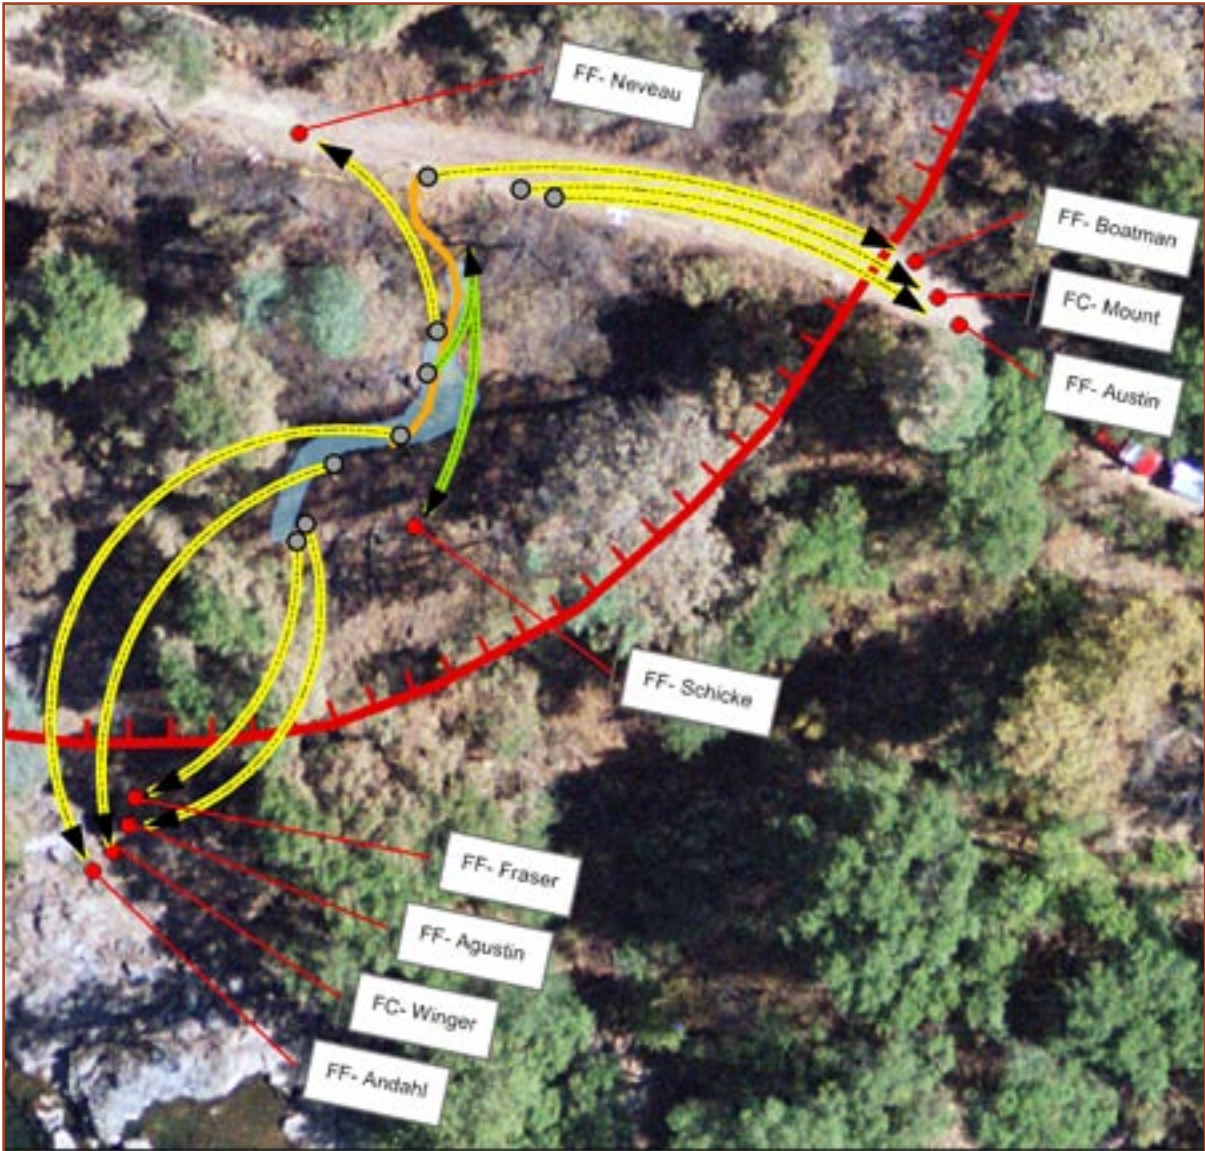
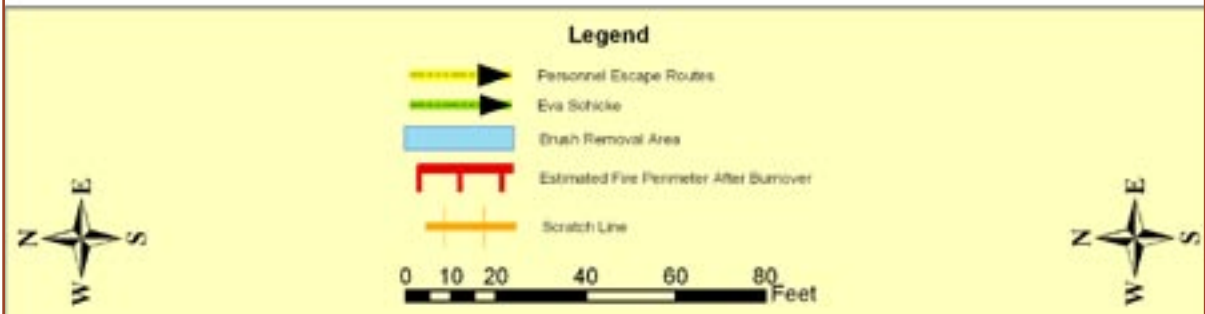
Post Burnover Crew Location

- ***The safety zone at the road was adequate, but required moving on the road into the green or into the black.*** FF Neveau reached the road and moved into the black. FF Boatman was on the road and moved into the green. Shelters were not deployed nor were they necessary. No injuries resulted once they reached the safety zone.

- ***The safety zone into the black was inadequate.*** Typically going into the cooled black is a primary safety zone. However, in this instance the black below the road proved to be too hot to remain without suffering injury. HC Winger and FF Andahl ran through flaming front into the black but believed it was too hot to stay there and turned downhill to reach the safety zone at the river. They did not deploy shelters either in the “black” or at the “river” safety zones. No injuries resulted once they reached the safety zones. Because of the flaming front and unburned fuel, escape into the black was not accessible to FF Neveau and FF Schicke.
