Point Fire Case Study

student handout

(adapted from PMS 419, BLM Engine Operator Training)

Date of Incident: July 28, 1995
Time of Incident: 1829 MDT
Incident Name: Point Fire

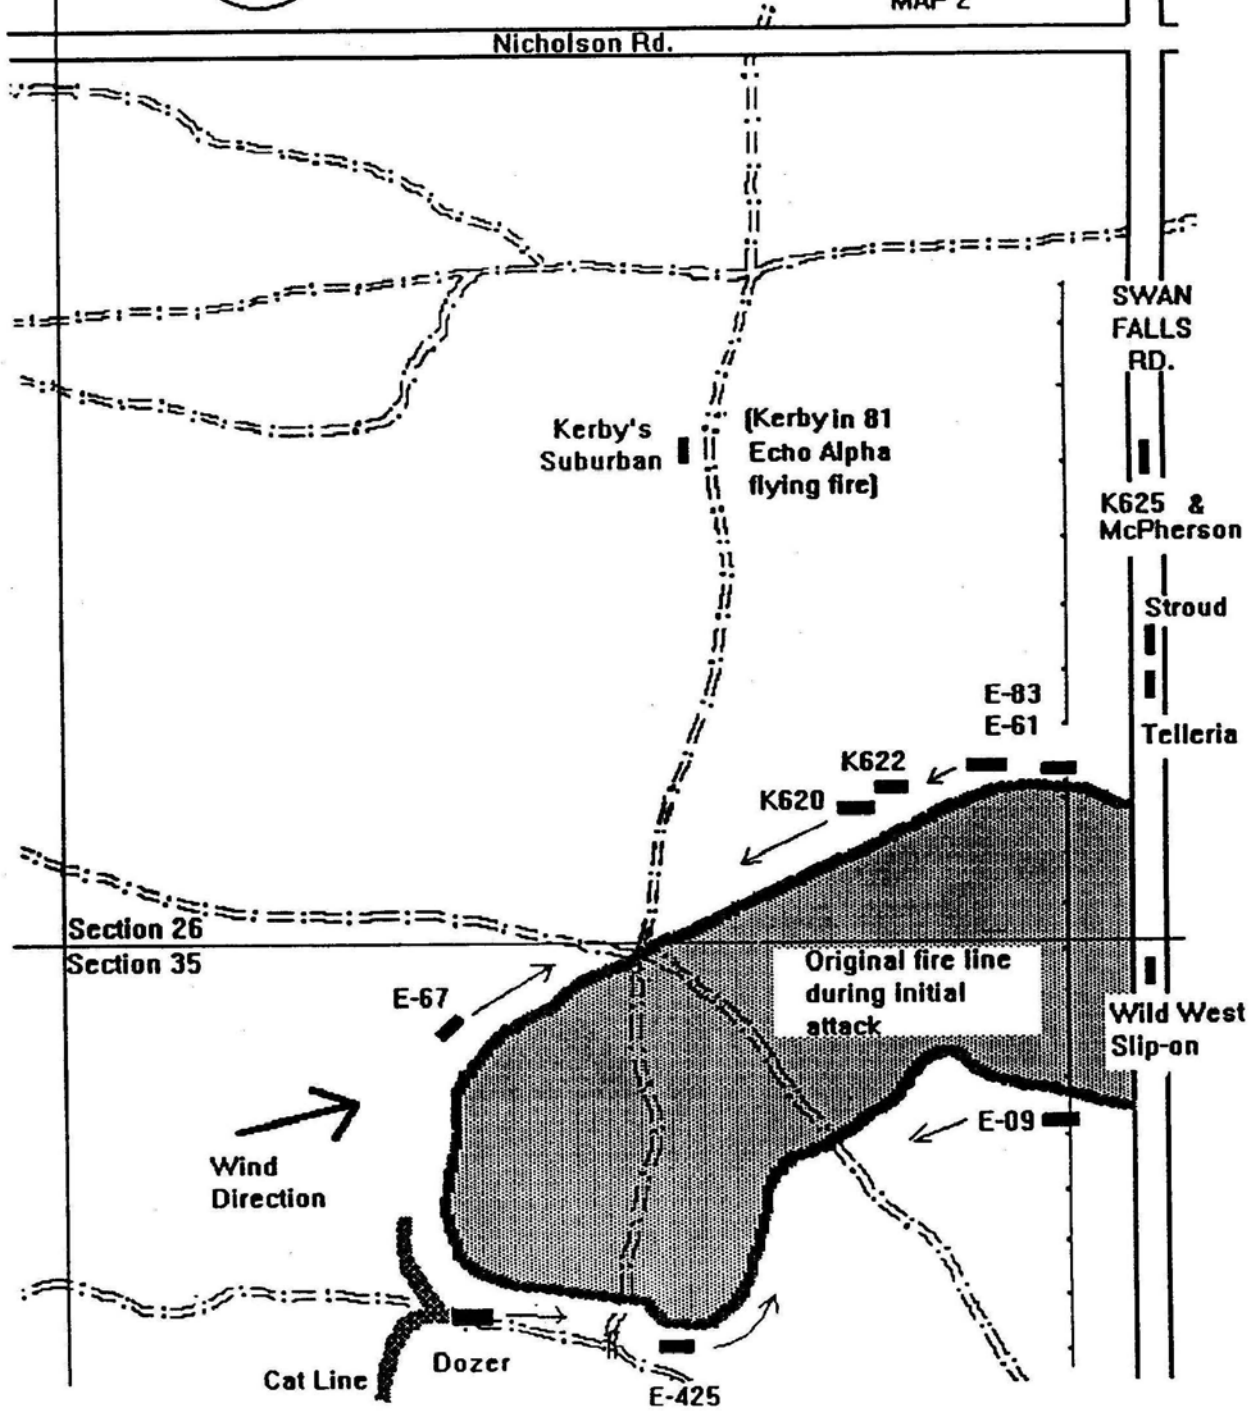
MAP 2

UNIT "C" ON LOCATION AT POINT FIRE
KUNA, IDAHO - TO ASSIST "WILD WEST".
KUNA UNITS ARRIVE WITH UNIT "C"
AT APPROXIMATELY 1930 HOURS 7-28-95

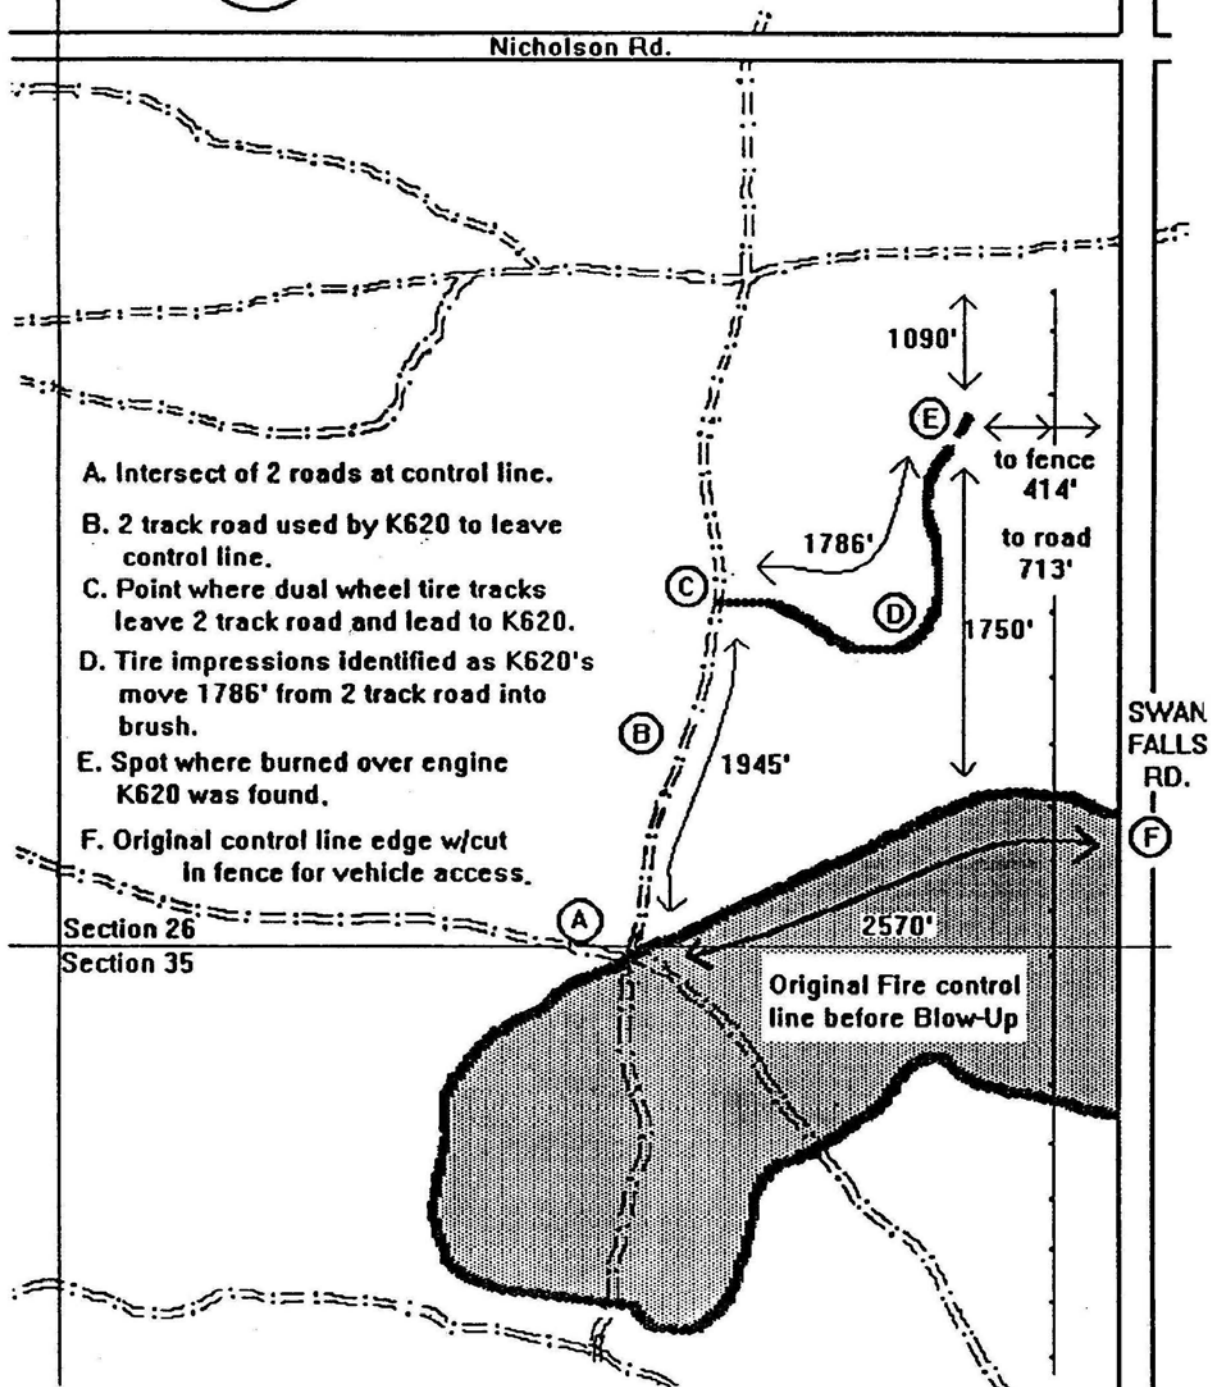
MAP 3

Sometime after Kuna RFD Engine 622 went to refill, Kuna RFD Engine 620 passed Engine 61 and Engine 67 on the west end of the fire line. Soon afterwards and for unknown reasons, Kuna RFD Engine 620 turned north on a two-track road at its intersection along the fire’s northern perimeter. (See Map 3, Point A.) Kuna RFD Engine 620 traveled along the two-track road for 1,945 feet (Point C), where it turned off the road and drove east and then north-northeast cross country another 1,786 feet through heavy sagebrush. At this point, the vehicle became disabled (Point E). The vehicle was 713 feet west of Swan Falls Road and 1,750 feet north of the northern fire perimeter.

SITE DESCRIPTION OF FATAL BURN-OVER
OF BRUSH ENGINE
KUNA, IDAHO 7-28-95

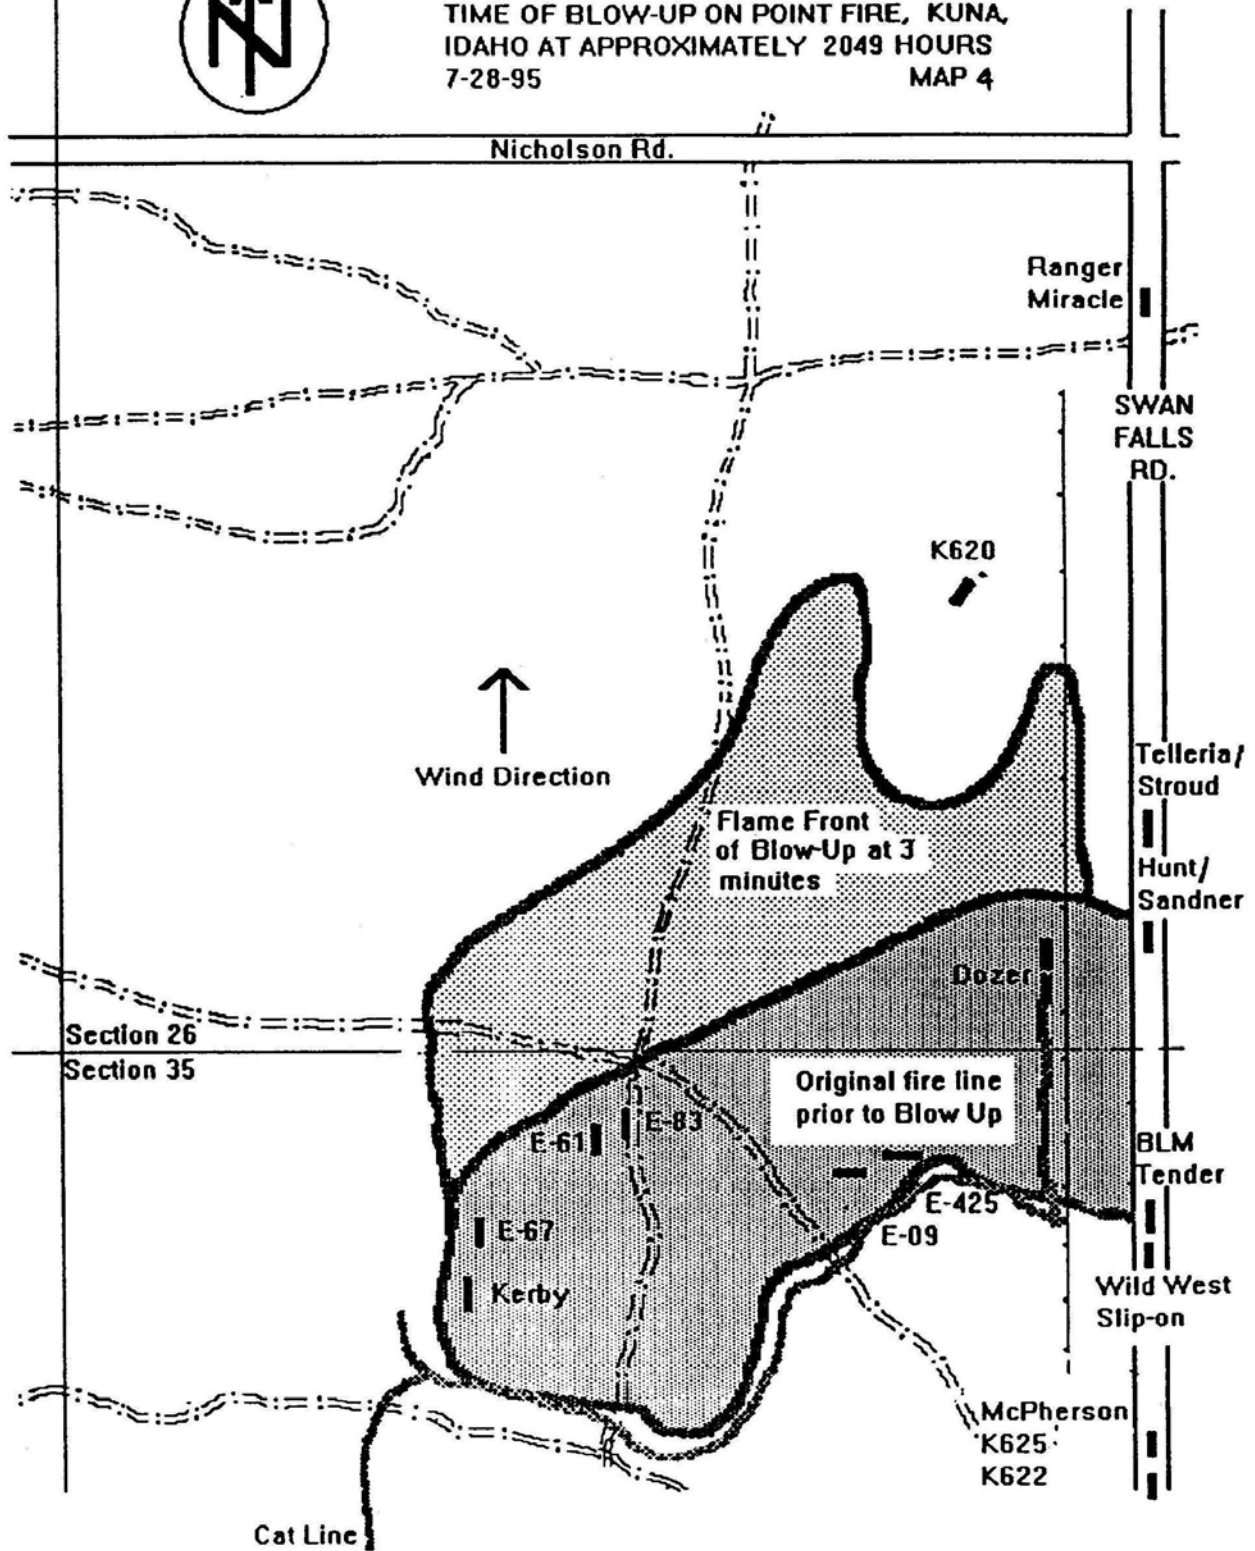
VEHICLE/CREW LOCATIONS KNOWN AT
TIME OF BLOW-UP ON POINT FIRE, KUNA,
IDAHO AT APPROXIMATELY 2049 HOURS
7-28-95
MAP 4
