South Canyon Fire Investigation

of the 14 fatalities
that occurred on
July 6, 1994 near
Glenwood Springs,
Colorado

**Report of the
South Canyon Fire
Accident Investigation Team**

August 17, 1994

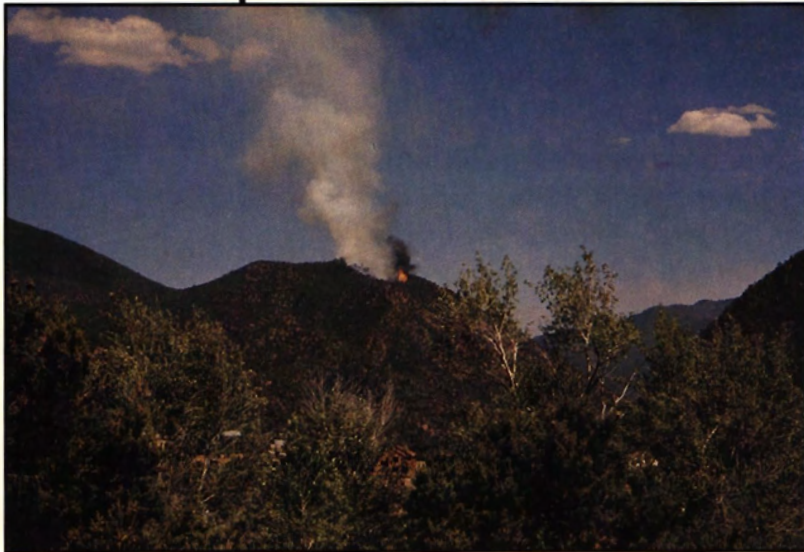
Photo 1. The South Canyon fire at noon on July 4.

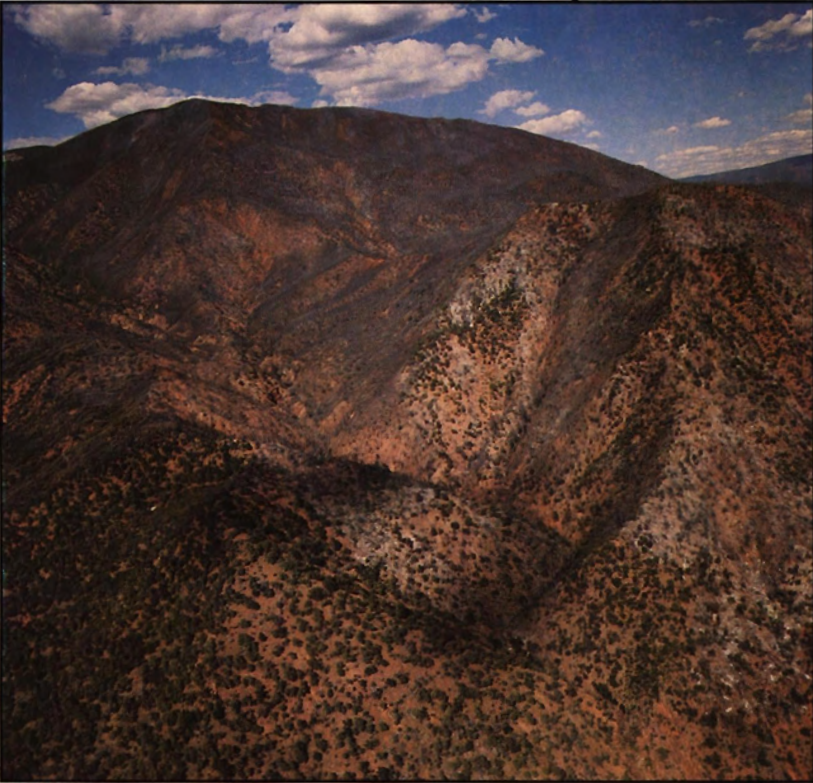
Photo 2. July 5 Tactical Map photo.

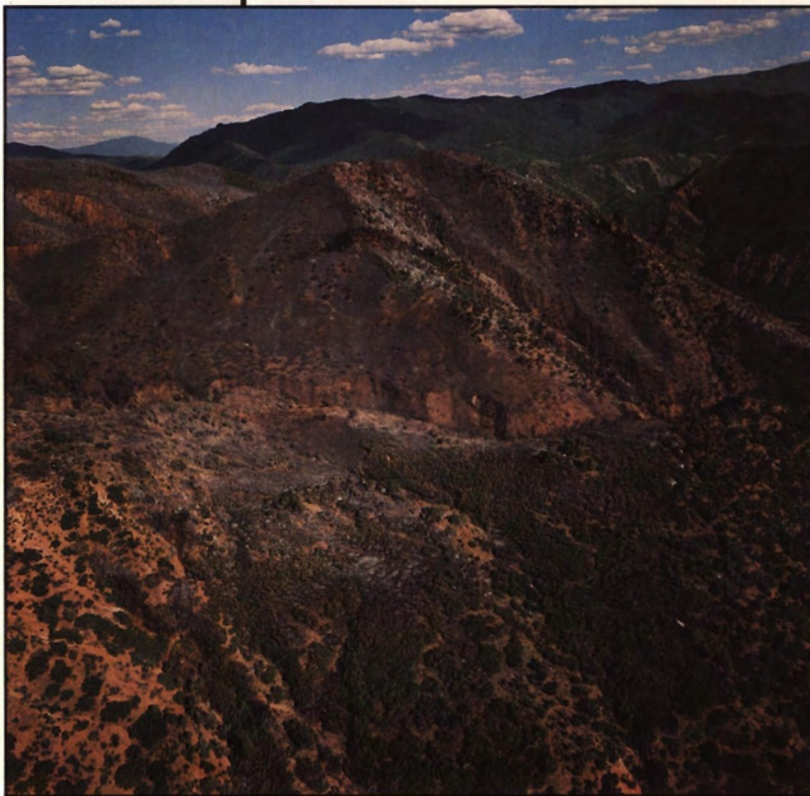
Photo 3. July 6 Tactical Map photo.

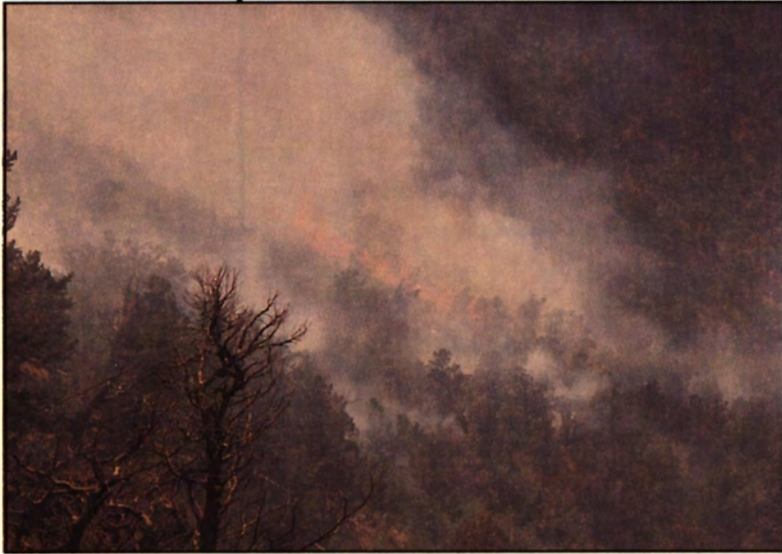
Photo 4. Fire behavior at 3:45 p.m.

At 3:45 p.m. the fire made several rapid runs with 100-foot flame lengths within the burned area just above the Line Scout. A short time later, helicopter water drops were called for on the west drainage and the ridgeline. At this point, fire activity was so intense that water drops were not effective. The people improving the handline noticed the activity and started walking out the fireline.

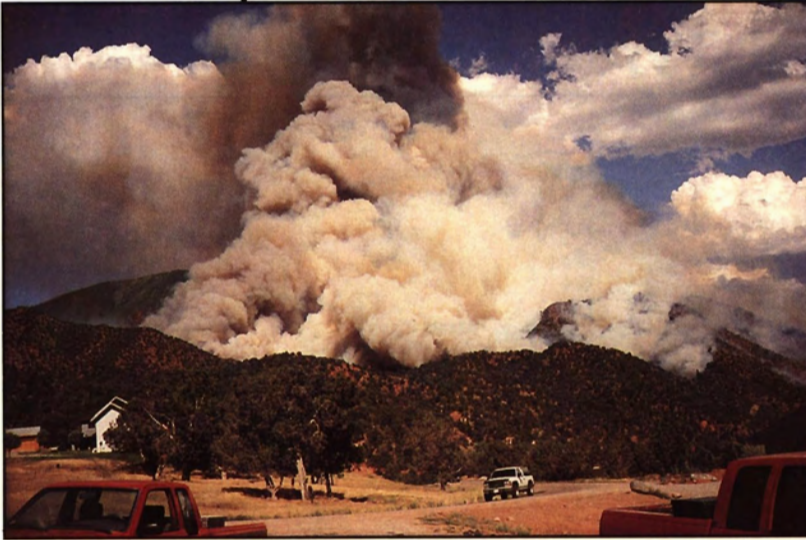
Photo 5. Blow up between 4:30 and 5:00 p.m.

Petrelli described the fire as he experienced it from his fire shelter: "When in the shelters, the fire made three different runs on our right side, approximately 200 yards away. Inside the shelter it heated up to 110 degrees. During the hottest run there were glowing fire brands blowing into the shelter. Between fire runs we would peek out (of) the shelter. There was still heavy smoke coming from below us. The wind was still blowing ash and dust."

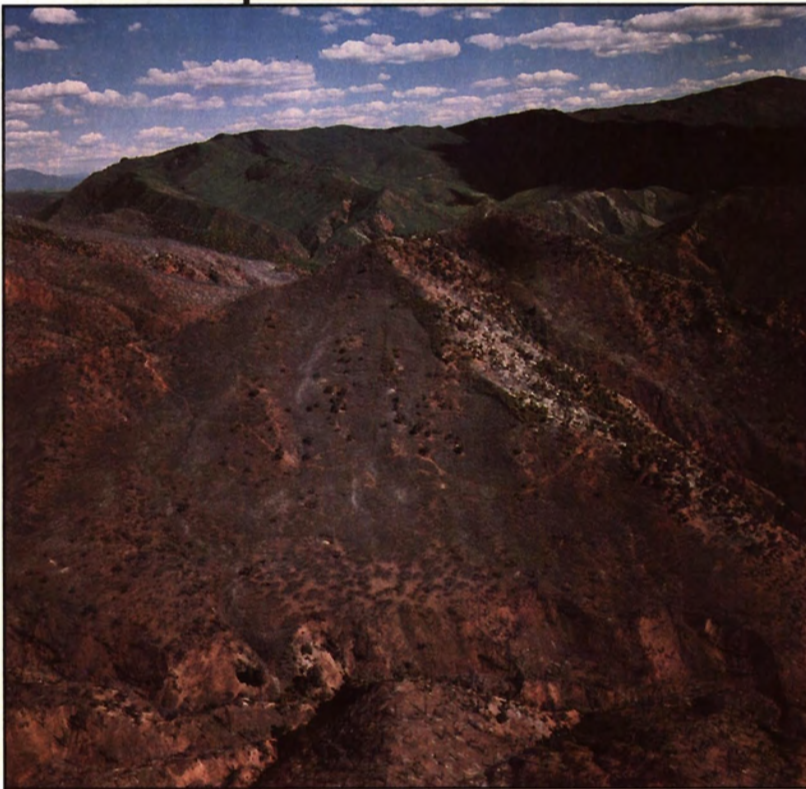
Photo 6. Fireline and deployment sites.

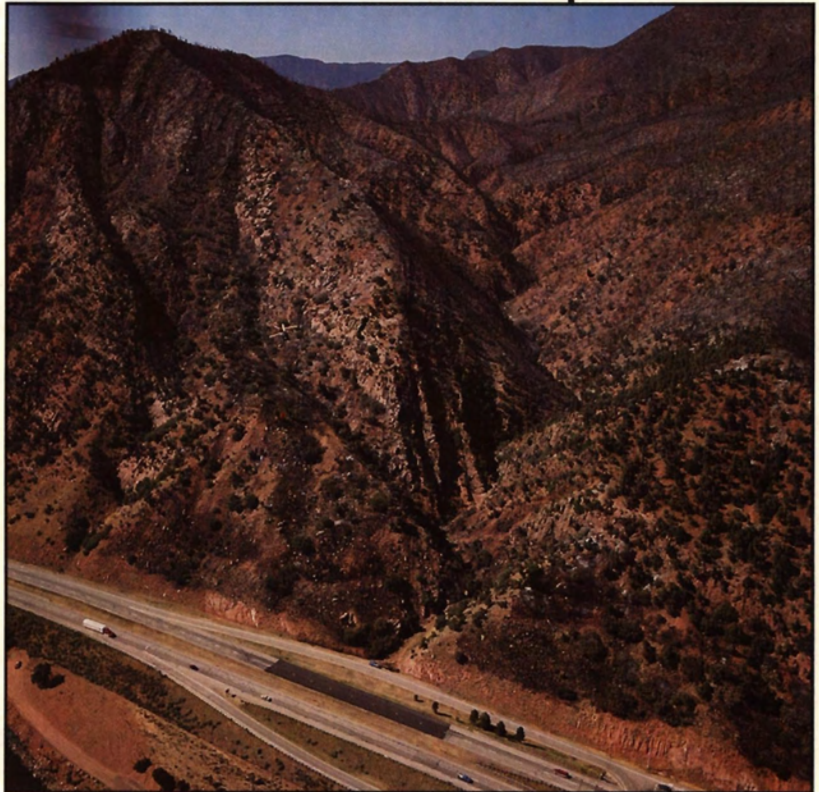
Photo 7. East drainage escape route.

Crews that dropped off the ridge fled down the east drainage. The wind blew the fire down this drainage, whose mouth was consumed in flames 30 to 40 minutes after the last firefighter escaped.

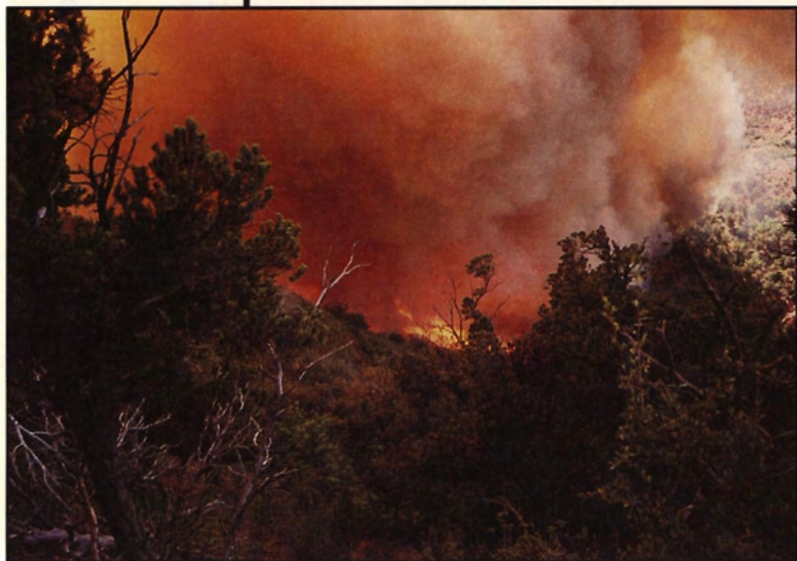
Photo 8. Spot fire approaching ridgeline.

ridge, and that was the first indication of how bad it had gotten....The fire storm literally exploded behind the ridge with approximately 100-foot flame height. At this point I decided I had to run. I can't recall if anyone was ahead of me or not, nor can I recall what the crew's reaction was to the blowup. As I neared the crest of the ridge, the heat was intense. I topped out and headed down the other side about 150 feet. When I turned around, a wall of flame 150 feet tall and 1/4 of a mile wide was on the ridgetop and starting to roll down the east side of the ridge."

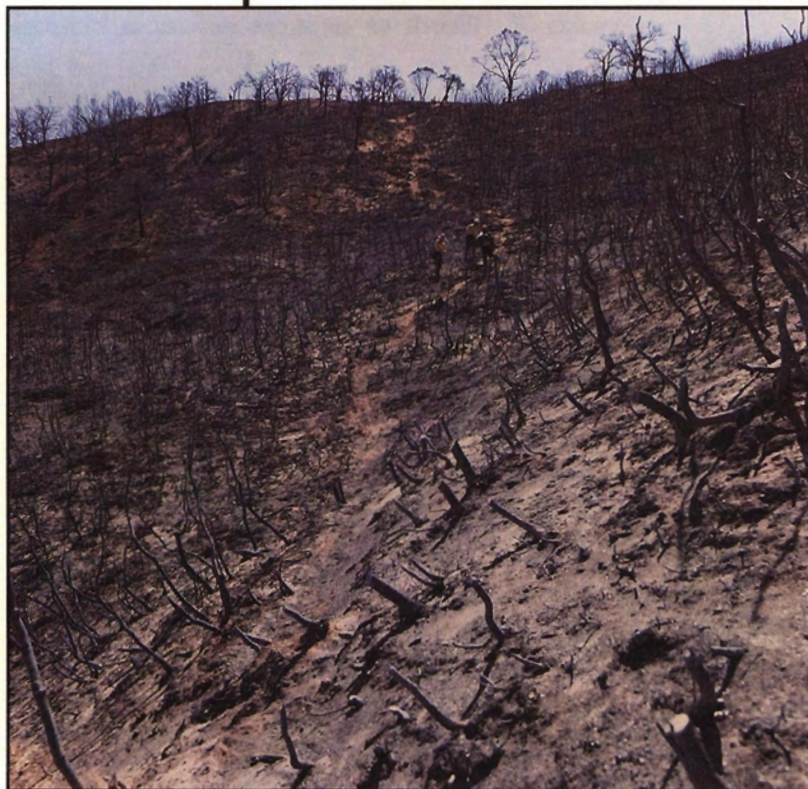
Photo 9. Fireline and fatality site.

deploy shelters. As the fire raced toward the crew, Erickson and Haugh, who were shouting encouragement, turned and ran for the ridgetop. They were quickly followed by Eric Hipke, who chose not to deploy his shelter but to make a run for it. As the three running firefighters dove over the ridgetop, 200-foot flames blasted over the ridge, and all three received burns. The last jumper over the ridge, Hipke, was knocked down by the force of heat and flames. Erickson and Haugh tended to Hipke's burns, and then all three followed the east drainage down to Interstate 70 and safety. Erickson guessed that the spot fire spread to the top of the ridge in a matter of 30 seconds.
