■ Appendices

Appendix A—Injuries

CDF HELITACK 404 CREW BURNOVER

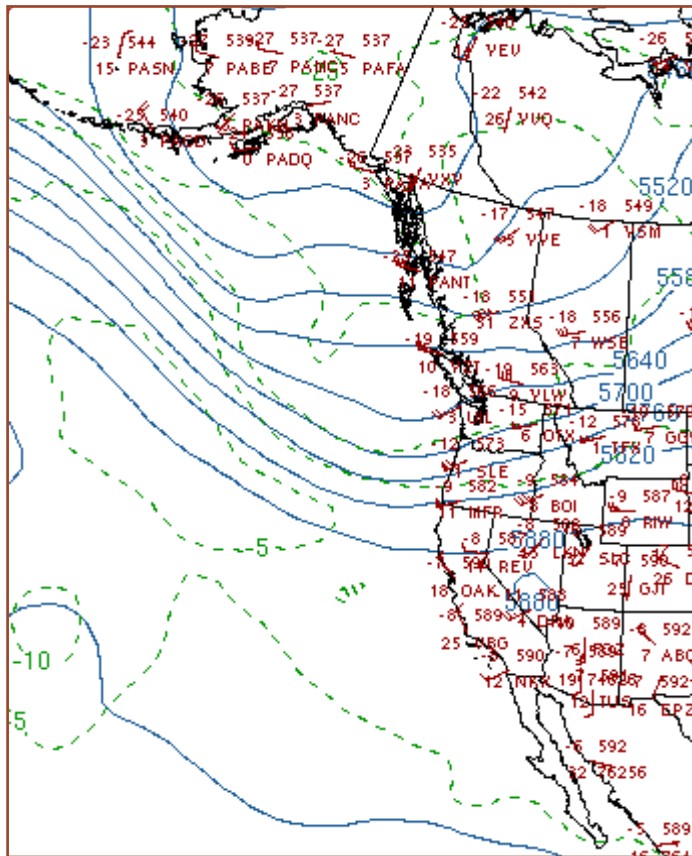
Figure 2: 500 mb Chart 9/11/04 1700 PDT

A fairly strong ridge of high pressure had been over the area for several days prior. Beginning the day before the entrapment (9/11/04), the southern edge of a low pressure trough began to move into Northern California (Figure 2).

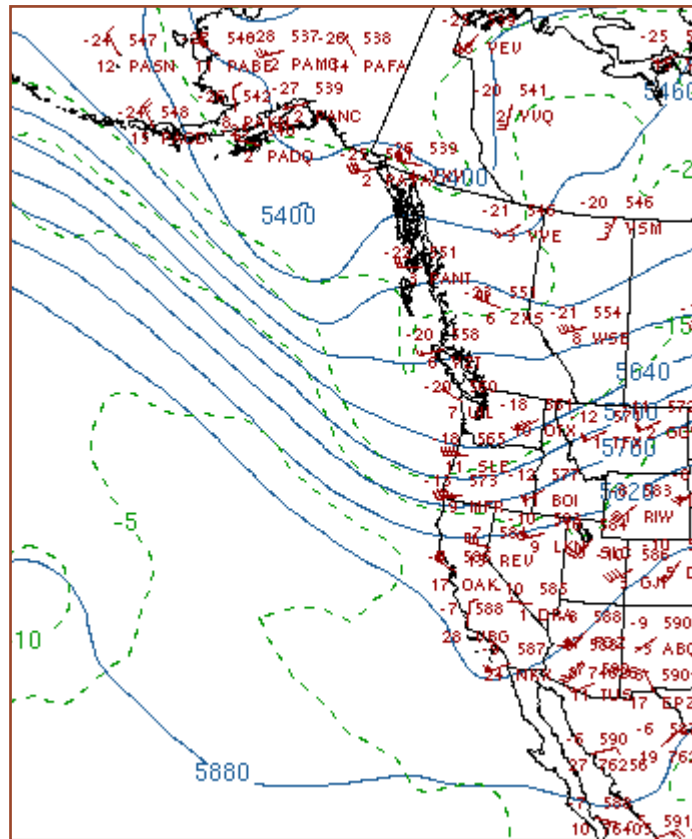
Figure 3: 500 mb Chart 9/12/04 1100 PDT

This trough continued moving inland and further south, passing over the fire area the day of the entrapment (9/12/04 – Figures 3 and 4). There were no severe fire weather patterns over the area (e.g. dry cold front passage, thunderstorms, etc.). The weather changes from the trough passage that occurred, compared to previous days, were: noticeably cooler temperatures, somewhat higher humidity and a slight increase in wind speeds.

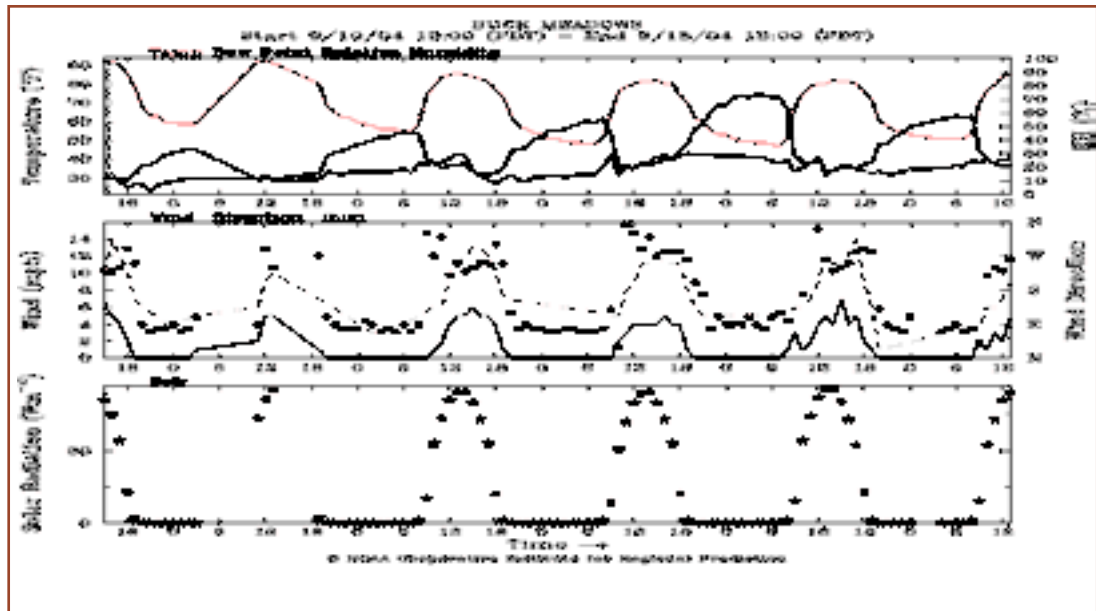
Graph 1: 5-day Weather Trends for Buck Meadow RAWS

As a result of the low pressure trough passing through, wind speeds at the nearby Buck Meadows RAWS were 1 to 2 mph stronger during the day of the entrapment compared to surrounding days (Graph 1). While the general wind direction over the area (SW to WSW) was basically aligned with the Tuolumne River canyon, there is no indication this resulted in stronger than normal winds near the river from air being funneled through the canyon. Wind speeds at the Buck Meadows RAWS were actually below average for the time of year (Graph 2).

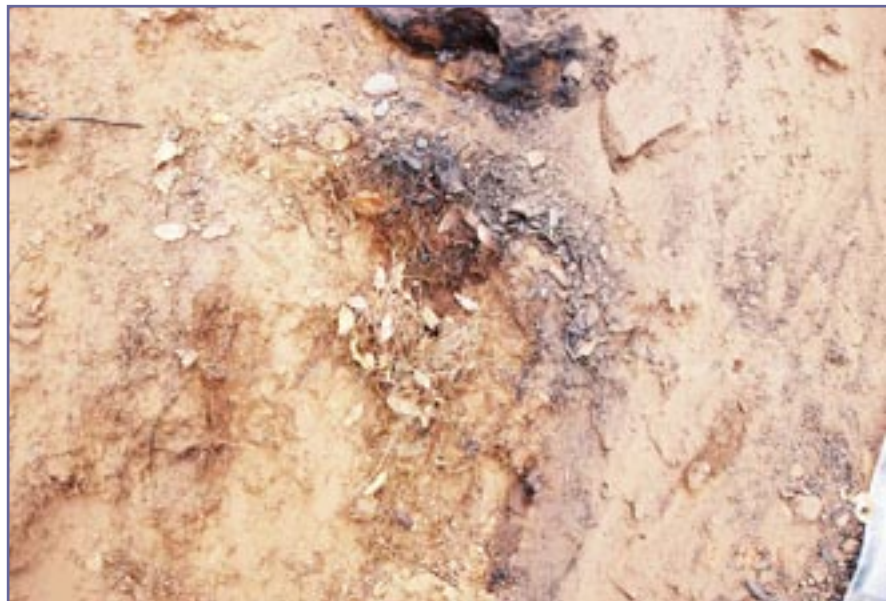
Photo H-23. Photo of unburned vegetation located under loose rock about 2.5 feet up-slope from body recovery site, indicating that this area was not burned at time rock slid to this location.
